**Final Report**  
**On**  
**Geo-Hazard Assessment of Different Vulnerable Areas of**  
**Gurbhakot Municipality**  
**Surkhet District**  
**Karnali Province**

**Submitted to**  
**Local Initiatives for Biodiversity, Research and Development (LI-BIRD)**

**Submitted by**  
**Himalayan Earth Science Research Center and Solutions Pvt. Ltd**

**2026**

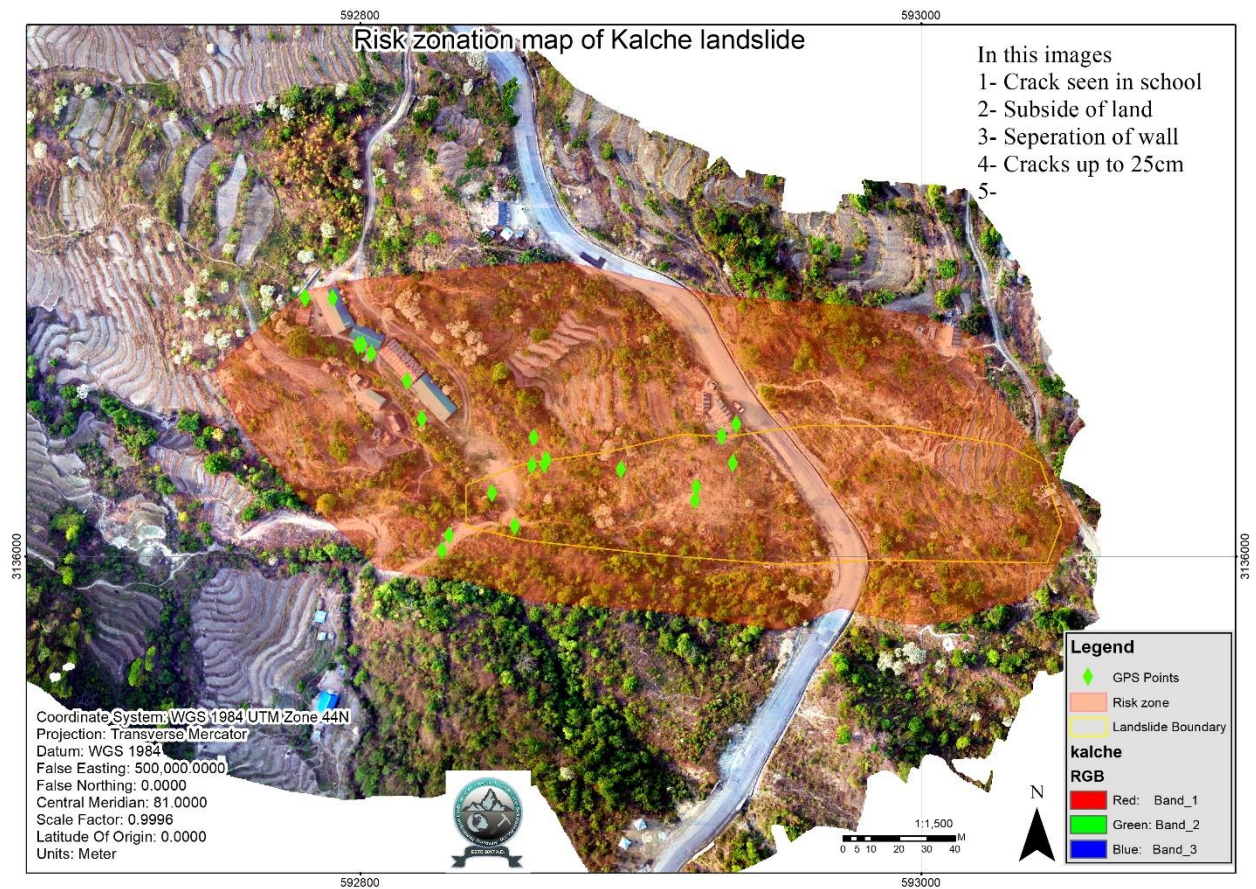
Figure 10: Photo Mosaic view with landslides boundaries from drone Images of Kalche Landslide, Gurbhakot-01.

Field observations indicate the presence of tension cracks at both the crown and within the main body of the landslide, suggesting past movement and potential for reactivation. Although no active movement is currently observed, the slope remains vulnerable.

The primary triggering factor appears to be gully erosion, which intensifies during the monsoon season. Significant soil loss occurs due to concentrated surface runoff. Additionally, the emergence of small springs, particularly during the monsoon, contributes to increased pore water pressure, further reducing slope stability. The downslope area is especially prone to instability due to continuous erosion. Nearby infrastructure, including a road and an existing school, lies within the potential impact zone and could be at risk during periods of intense rainfall.

At present, some stabilization measures have been implemented, including gabion walls along the road cut and downslope sections, which provide partial protection.

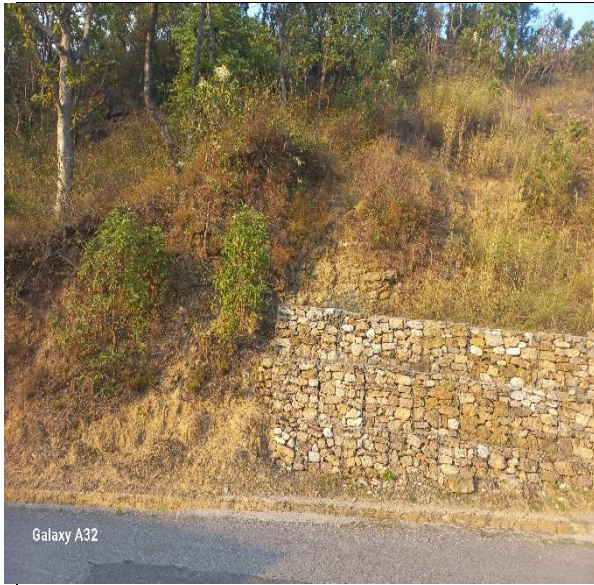
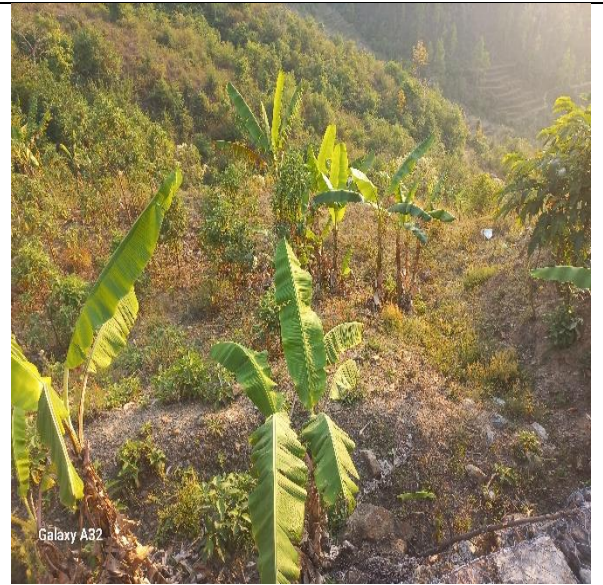
Figure 12 Glimpse of instability scenarios over the Kalche landslide.

| Mitigation | Drainage, gabion walls, bioengineering |
| Urgent Needs | Drainage control, slope stabilization |

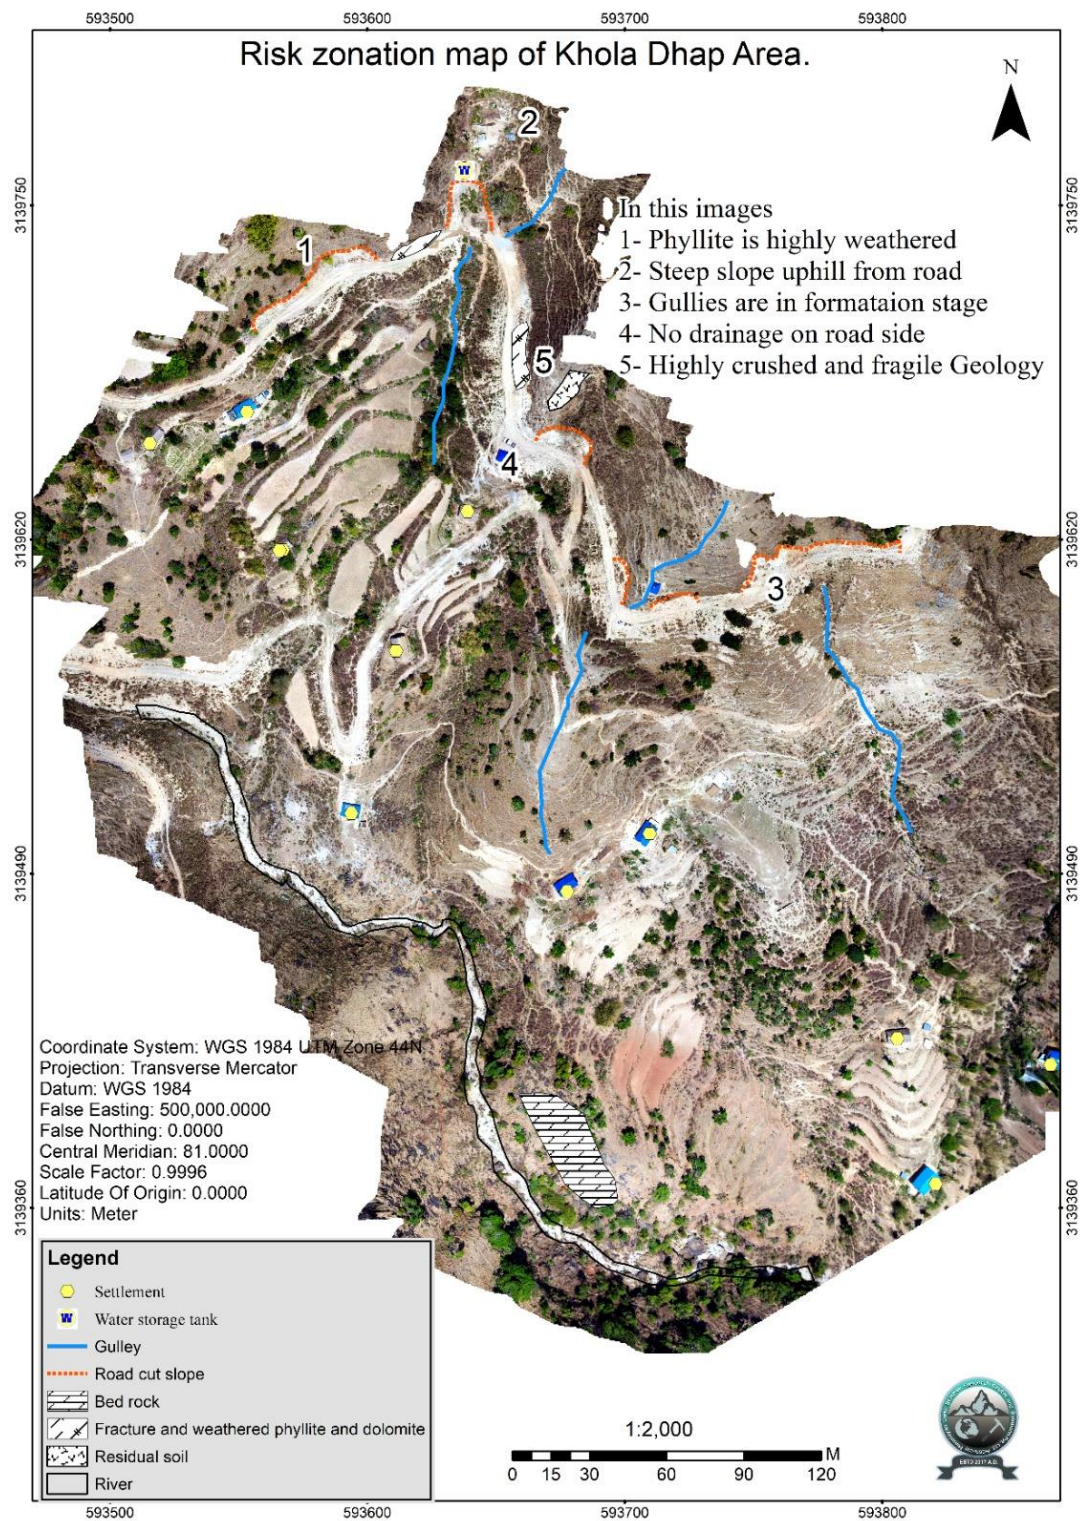
Figure 13: Photo Mosaic view with landslides boundaries from drone Images of Khola Dhab Landslide, Gurbhapot-02.

The affected area is mainly covered by residual soil deposits developed over weathered slope materials. The slope is generally mild in gradient and used for seasonal agricultural activities that largely depend on monsoon rainfall. Geologically, the area consists of red purple shale and phyllite is present throughout area. The dipping of the bedrock dip toward the north; however, no observed rock failure at the present condition.

The main geomorphological problem observed in the site is active gully erosion along the gully nearby cultivated land. During the monsoon season, several natural springs are originated throughout the village. Surface runoff during heavy rainfall erodes the loose residual soil and transports debris downslope through small tributary channels towards the houses. No major tension cracks or large scarps were identified during field observation, suggesting that the current instability is primarily erosional rather than deep-seated sliding.

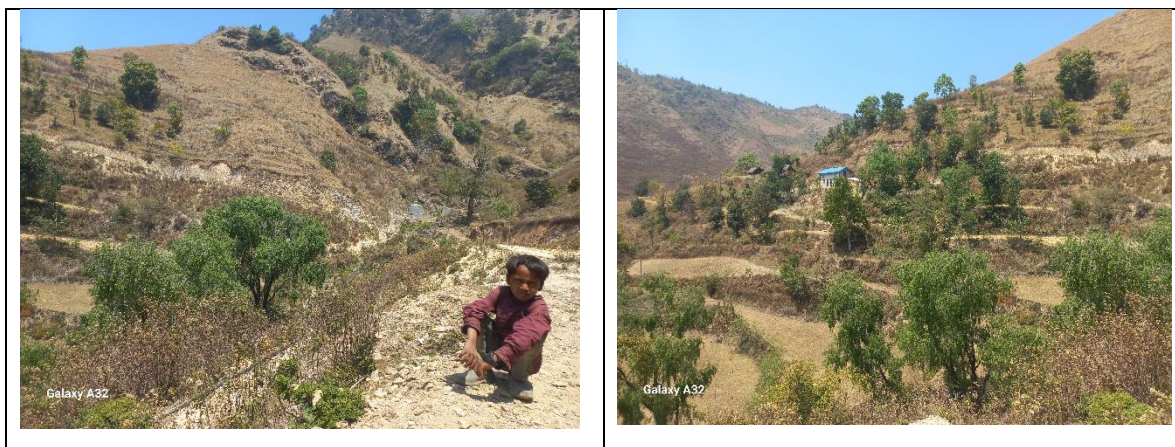
Figure 115: Photographs of instability area of Khola Dhab landslide zone

| Mitigation | Drainage improvement, diversion of water of springs |
| Urgent Needs | Gully management, surface drainage control, erosion protection |

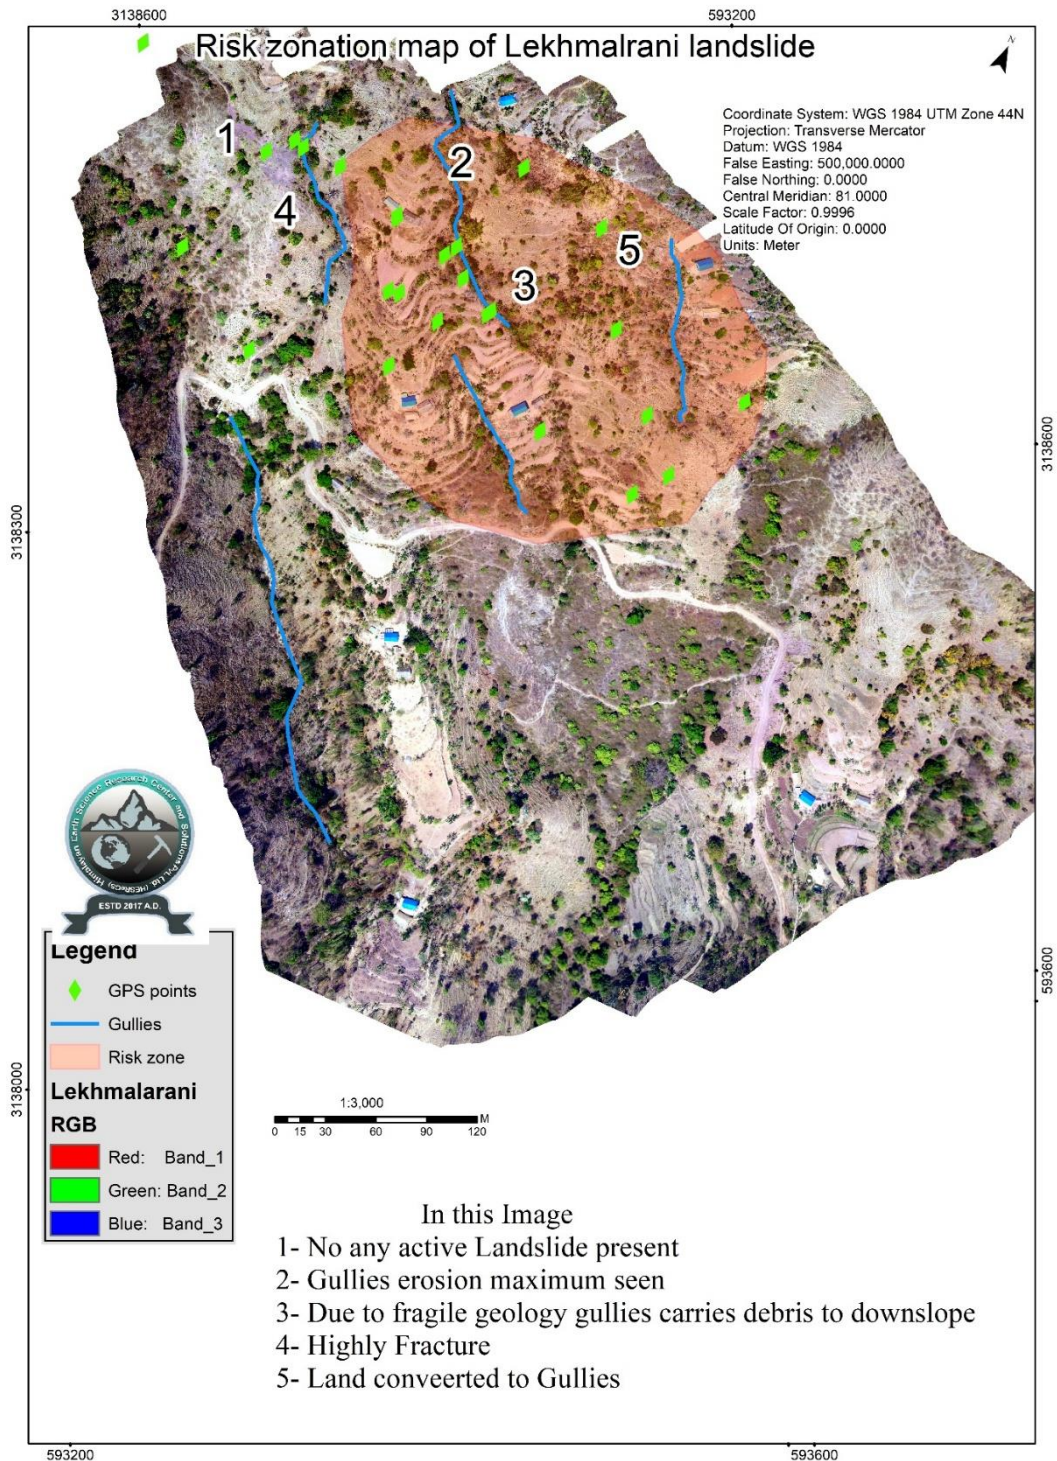
Figure 16: Photo Mosaic view with landslides boundaries from drone Images of Lekh Malarani Landslide, Gurbhakot-02.

The study area is underlain by highly weathered red-purple shale, slate, sandstone, and dolomite belonging to the Surkhet Group. The surface is predominantly covered by residual soil deposits distributed throughout the cultivated land. These soils are relatively loose and vulnerable to erosion during periods of heavy rainfall.

Topographically, the area consists of mild to gentle slopes with some saddle-shaped spur features. Two to three gullies are present within the settlement area, contributing to localized erosion and instability. The observed landslide is characterized as a very small-scale soil slide associated with weathered residual soil. The primary causes of instability include weathering of rocks, formation of weak residual soil, seasonal monsoon rainfall, and uncontrolled surface runoff. Rill and gully erosion are actively occurring within cultivated land, particularly during intense rainfall events. Although no major active scarp or deep-seated movement was observed during the field investigation, the slope remains sensitive to continued erosion and saturation.

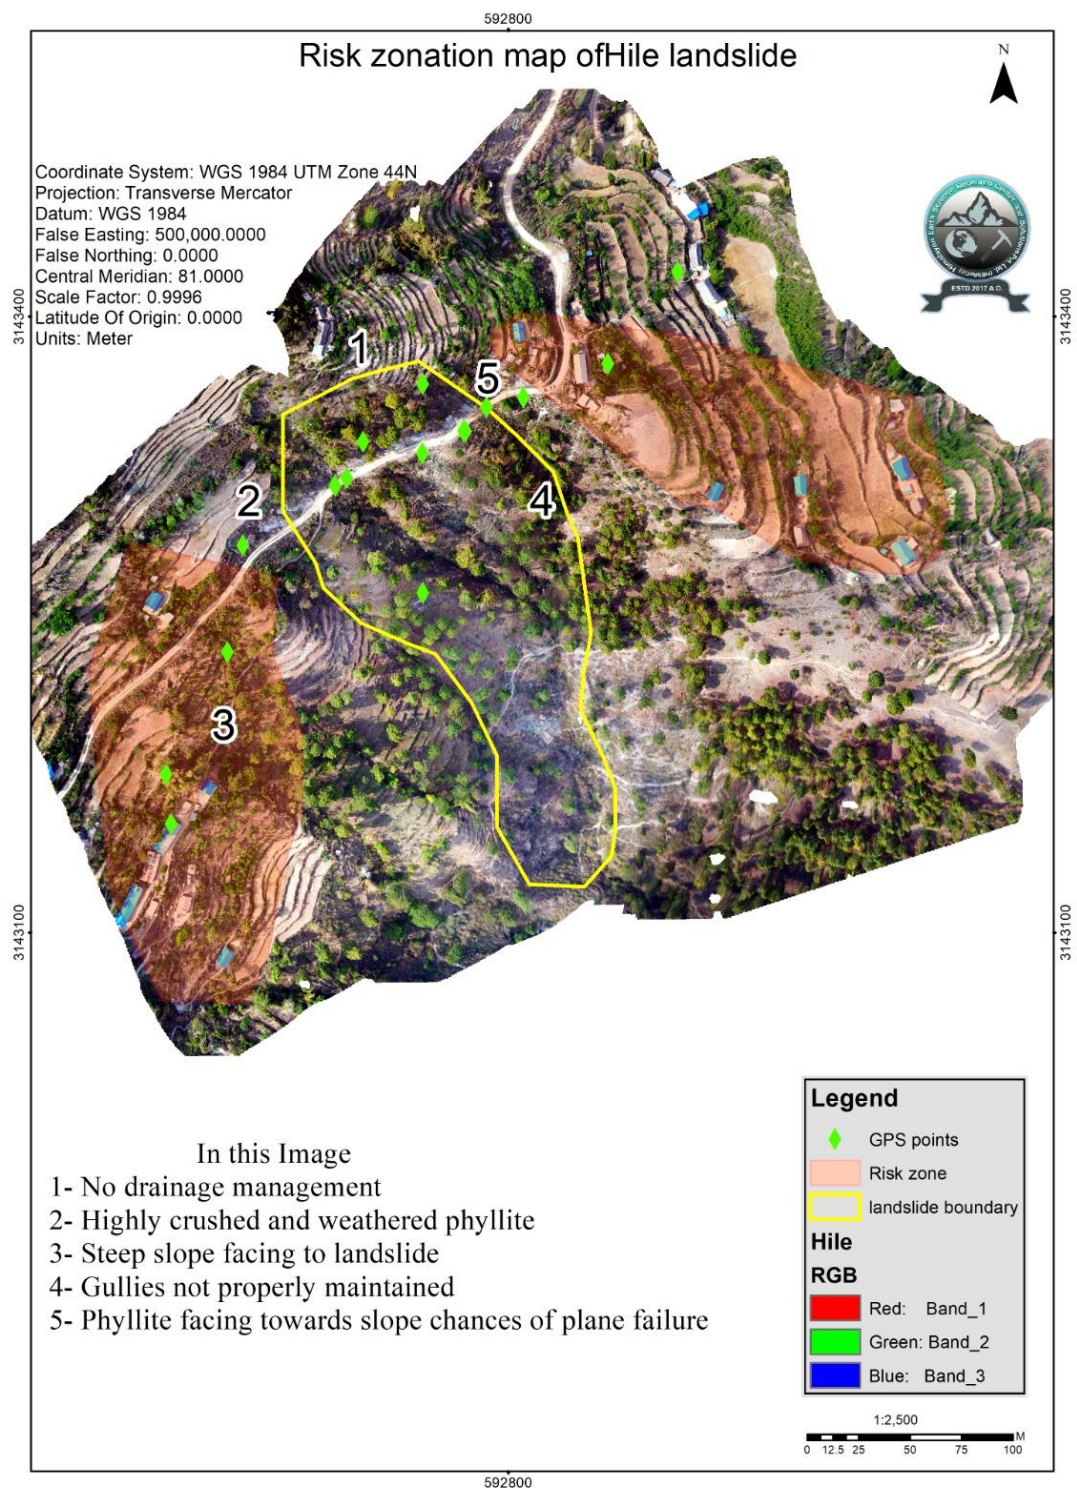
Figure 19: Photo Mosaic view with landslides boundaries from drone Images of Hile Landslide, Gurbhakot-03.

Geologically, the study area is characterized by the presence of phyllite, shale which is intercalated with grey dolomite and some quartzite beds. The topographical conditions of the Hile settlement are characterized by moderate to steep slopes, which inherently increases the risk of gravitational failure. The root cause of the stability problem is identified as fragile geology. The engineering geological assessment notes that the downslope consists of a colluvial mass colluvial debris making it highly susceptible to subsidence.

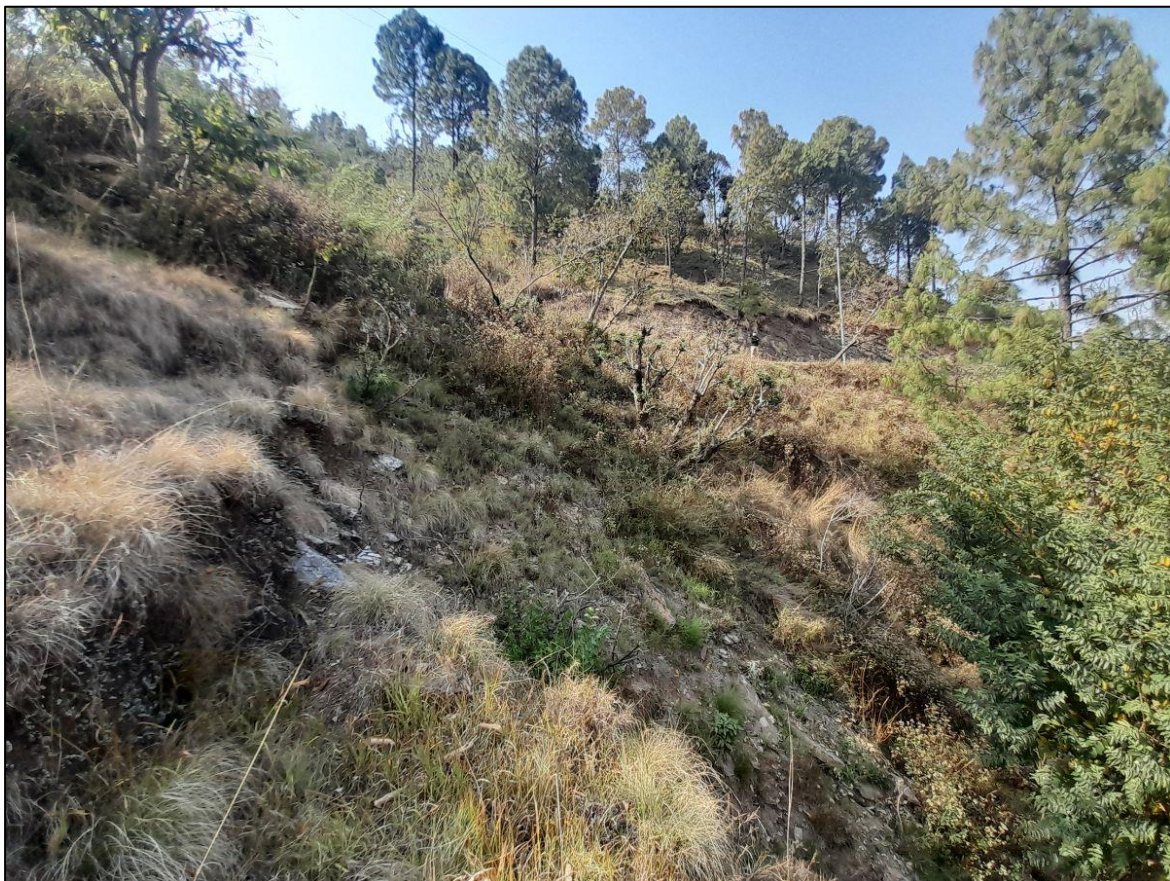
| Risk level at the community | Medium (category 2) |

Figure 21 Representative photo of the geo hazard problem adjacent to the settlement slope

| Treatability Status | Gabion wall on uphill from road and benching of slope in downslope |

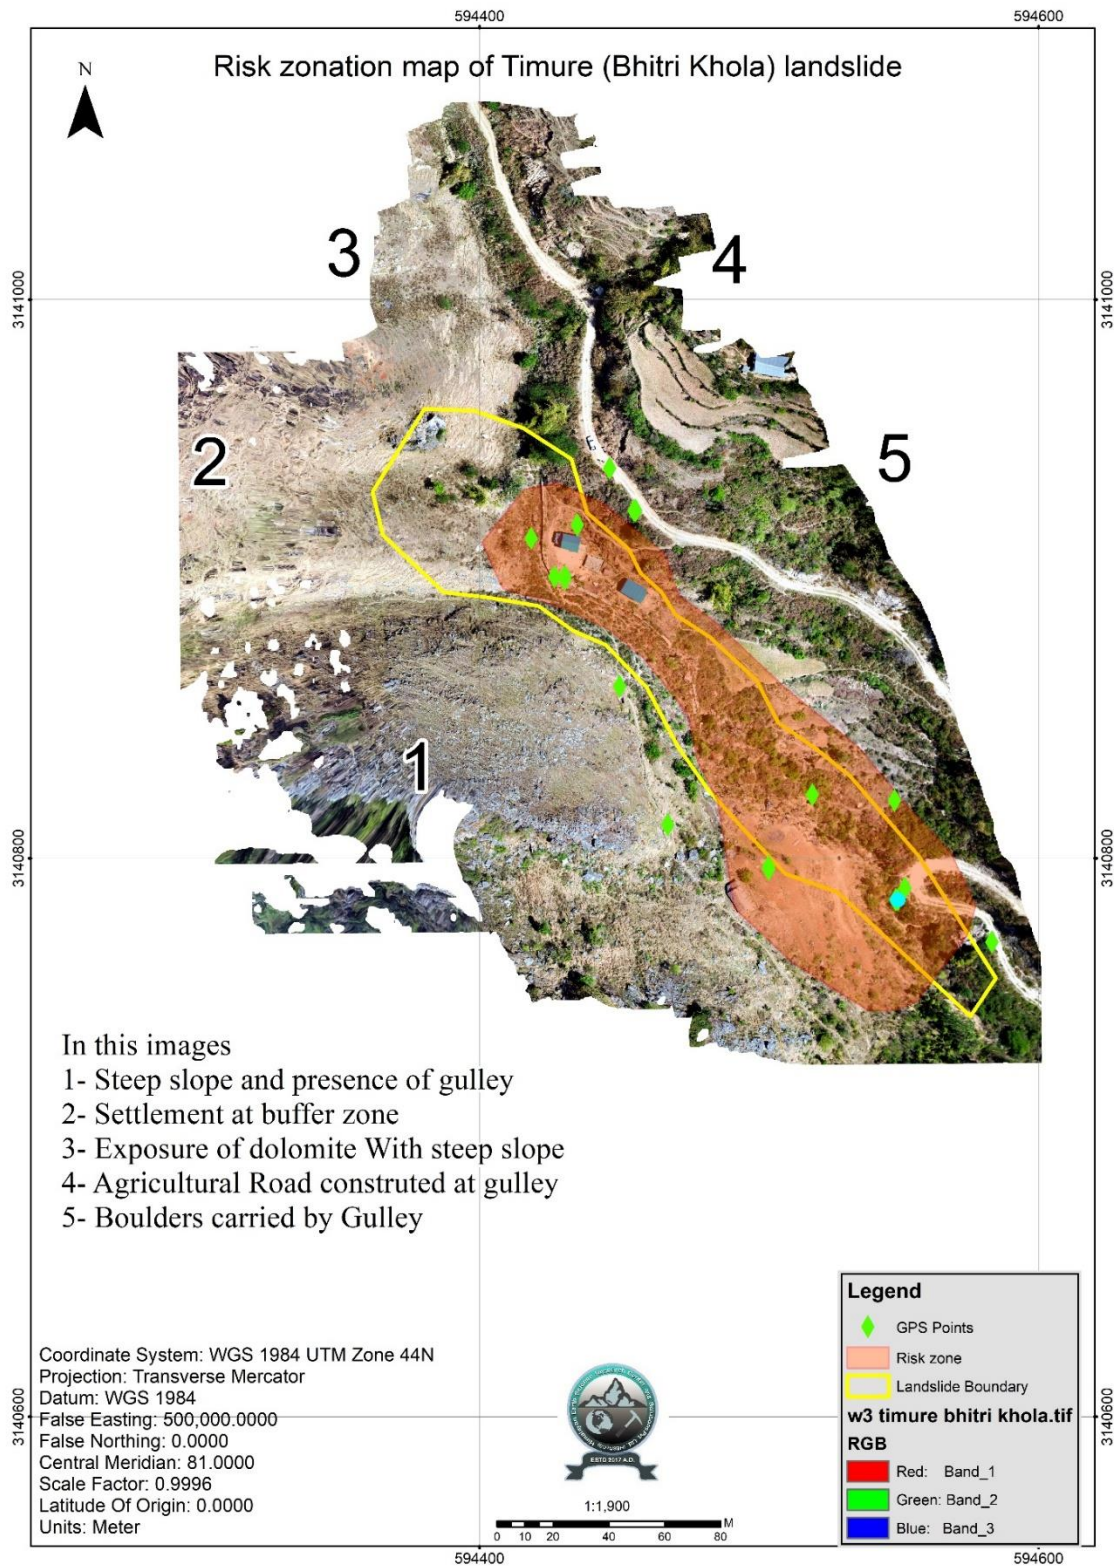
Figure 22: Photo Mosaic view with landslides boundaries from drone Images of Timure/ Bhitrikhola Landslide, Gurbhakot-03.

Geologically, the assessment site is characterized by a bedrock of dolomite and phyllite. The topographical conditions of the Timure/ Bhitri khola settlement are defined by steep slopes, which contribute to the debris flow hazard. The root cause of the stability problem is identified as intense rainfall acting upon the local geomorphology.

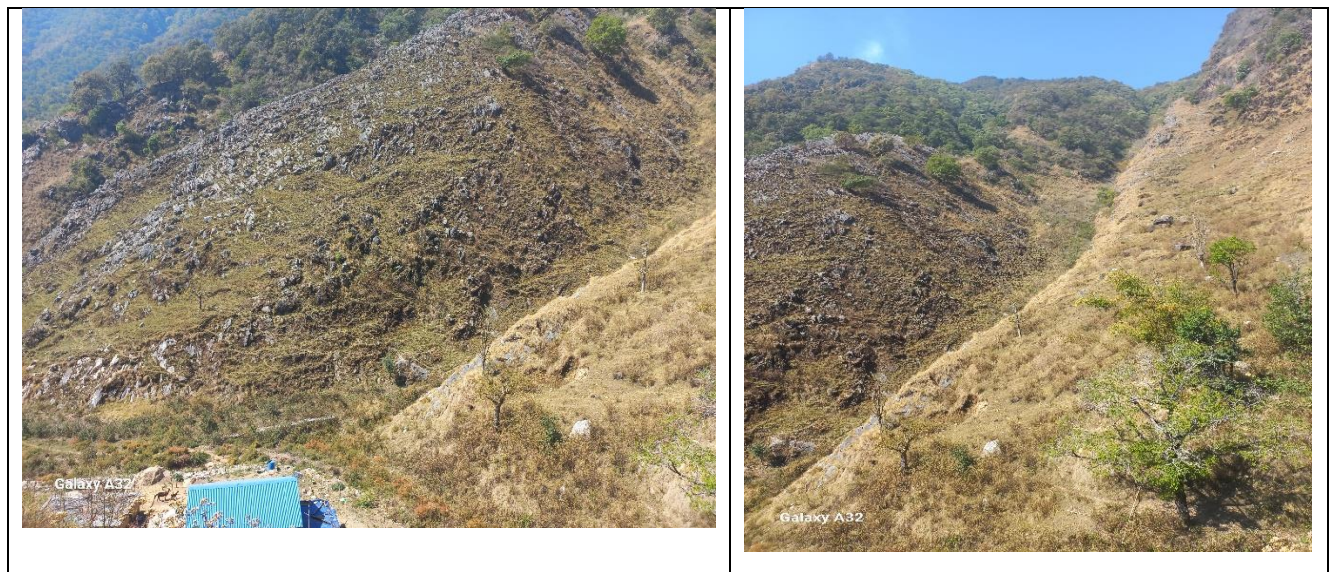
| Risk level at the community | High (Category 3) |

Figure 24: Photographs indicates the view of debris flow gully and risk zone of the Bhitrikhola landslide

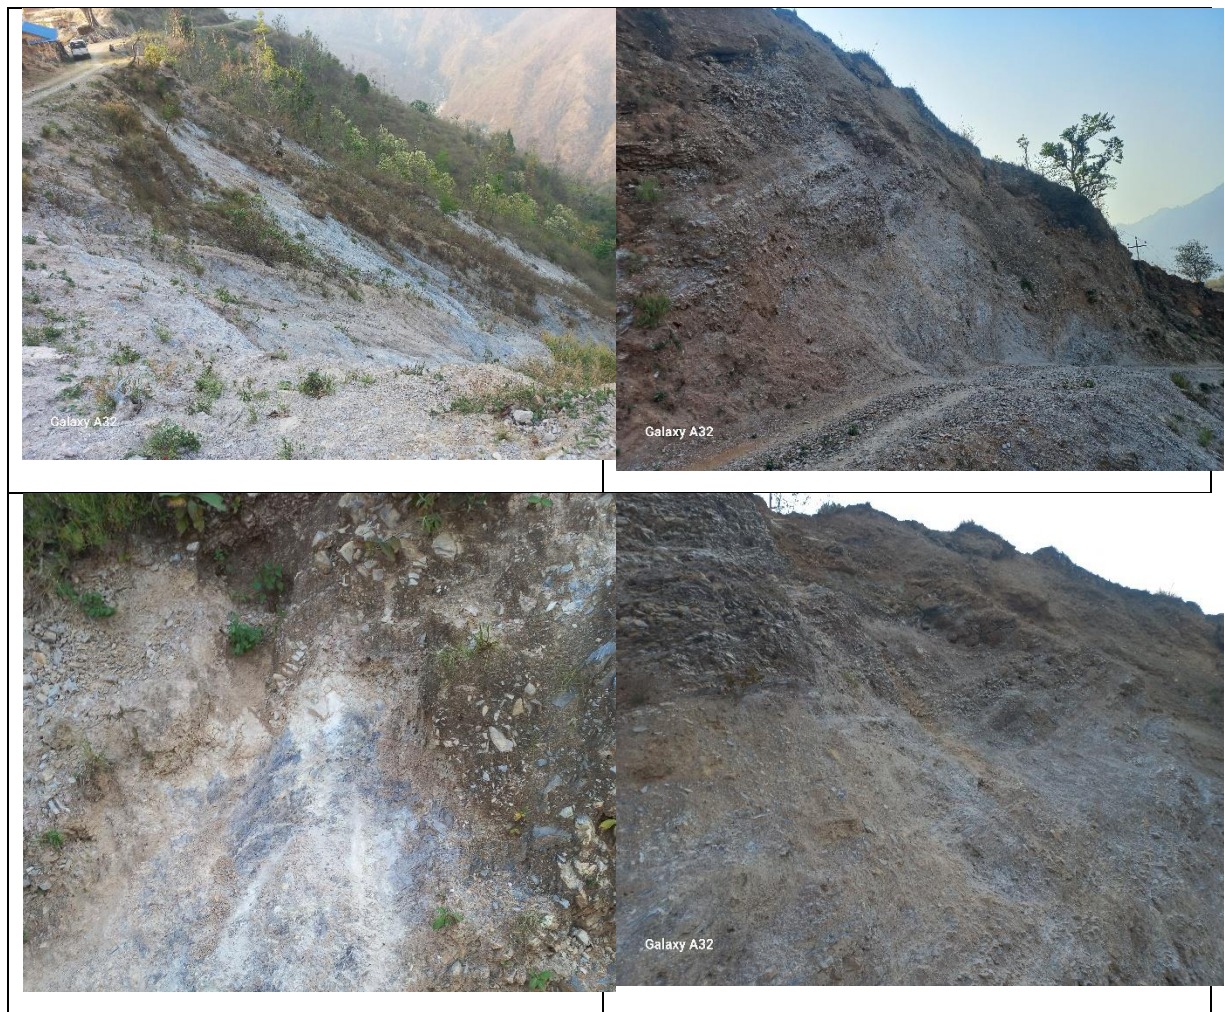
| Risk level at the community: | High (Category 3) (but no relocation) |

Figure 25: Photographs showing detail view of Lekh Kurule landslides with sheared zone

| Treatability Status: | Treatable with detail study, proper engineering structure for road cut slope protection, drainage surface and subsurface management. |

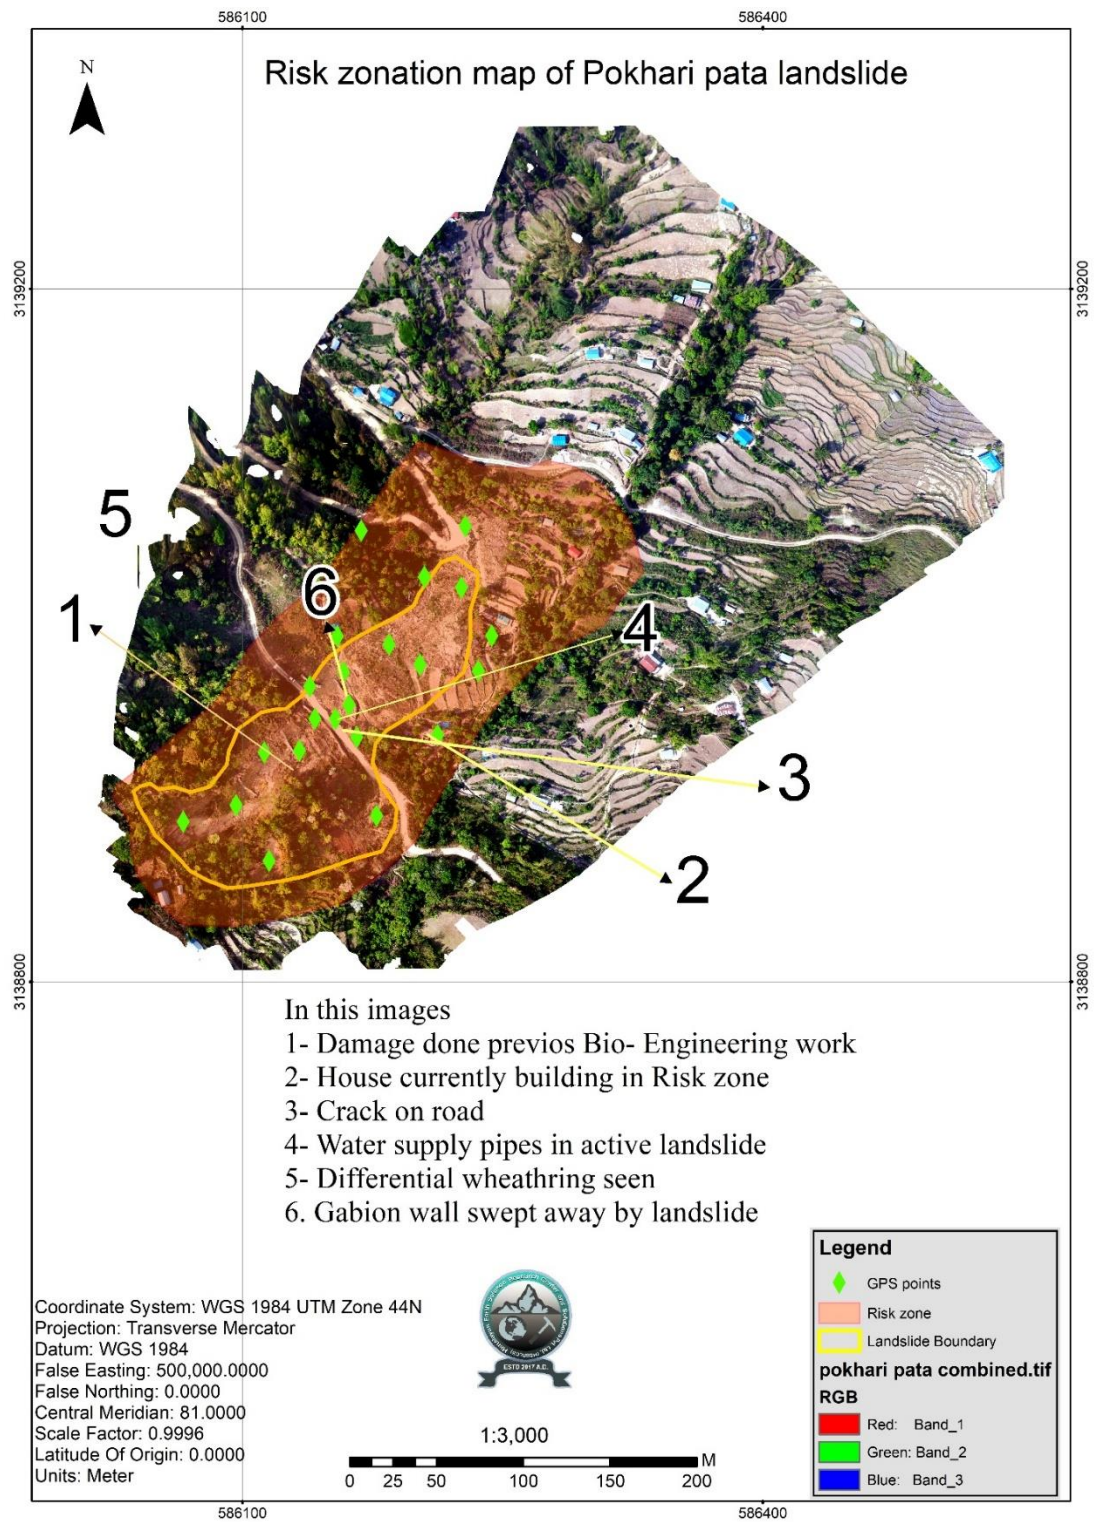
Figure 26: Photo Mosaic view with landslides boundaries from drone Images of Pokhari Pata Landslide, Gurbhakot-05.

The geological condition of the area is dominated by sedimentary rock sequences composed mainly of interbedded sandstone and mudstone. The mudstone layers are highly weathered and comparatively weak, while sandstone beds are relatively stronger and more resistant. Differential weathering between these lithological units has created unfavorable slope conditions. Engineering geological investigation also identified cracks on the road surface and near the crown portion of the landslide, indicating active slope movement.

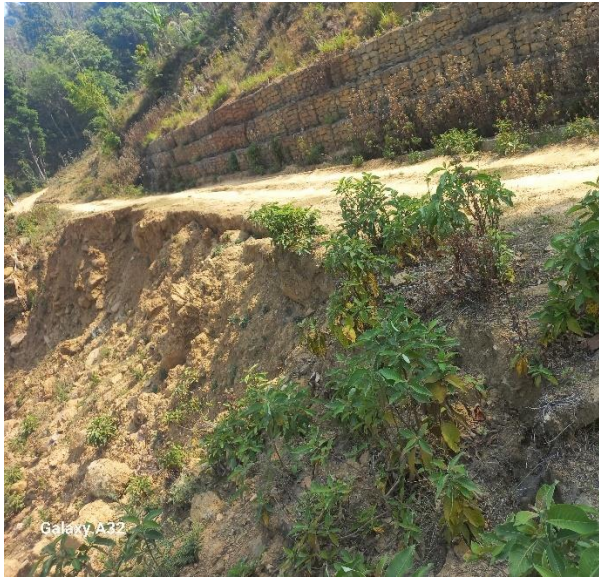
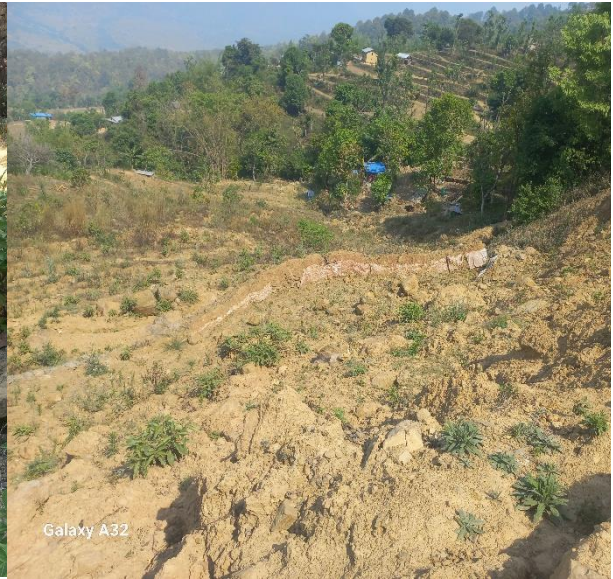
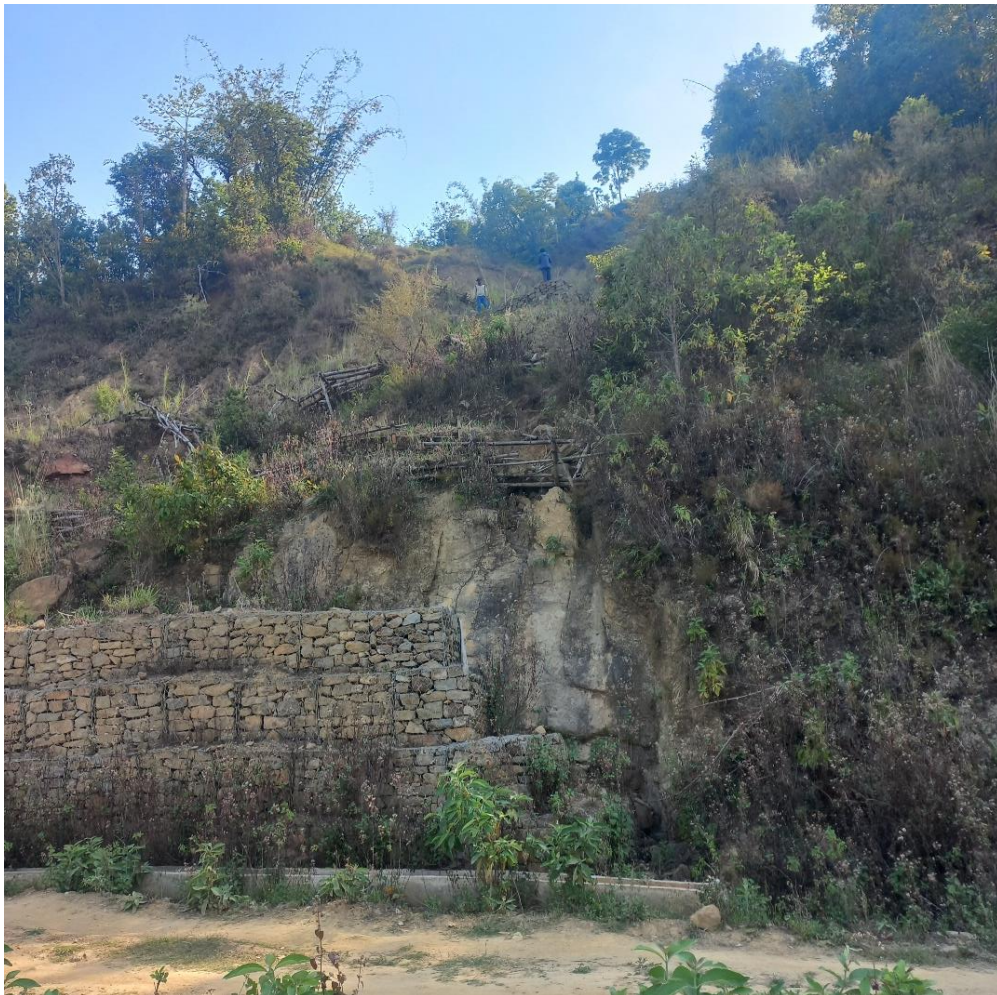
Figure 28: Details view of Pokari Pata landslide

| Treatability Status | The landslide is treatable with detailed engineering geological and geotechnical investigation followed by appropriate stabilization measures. |

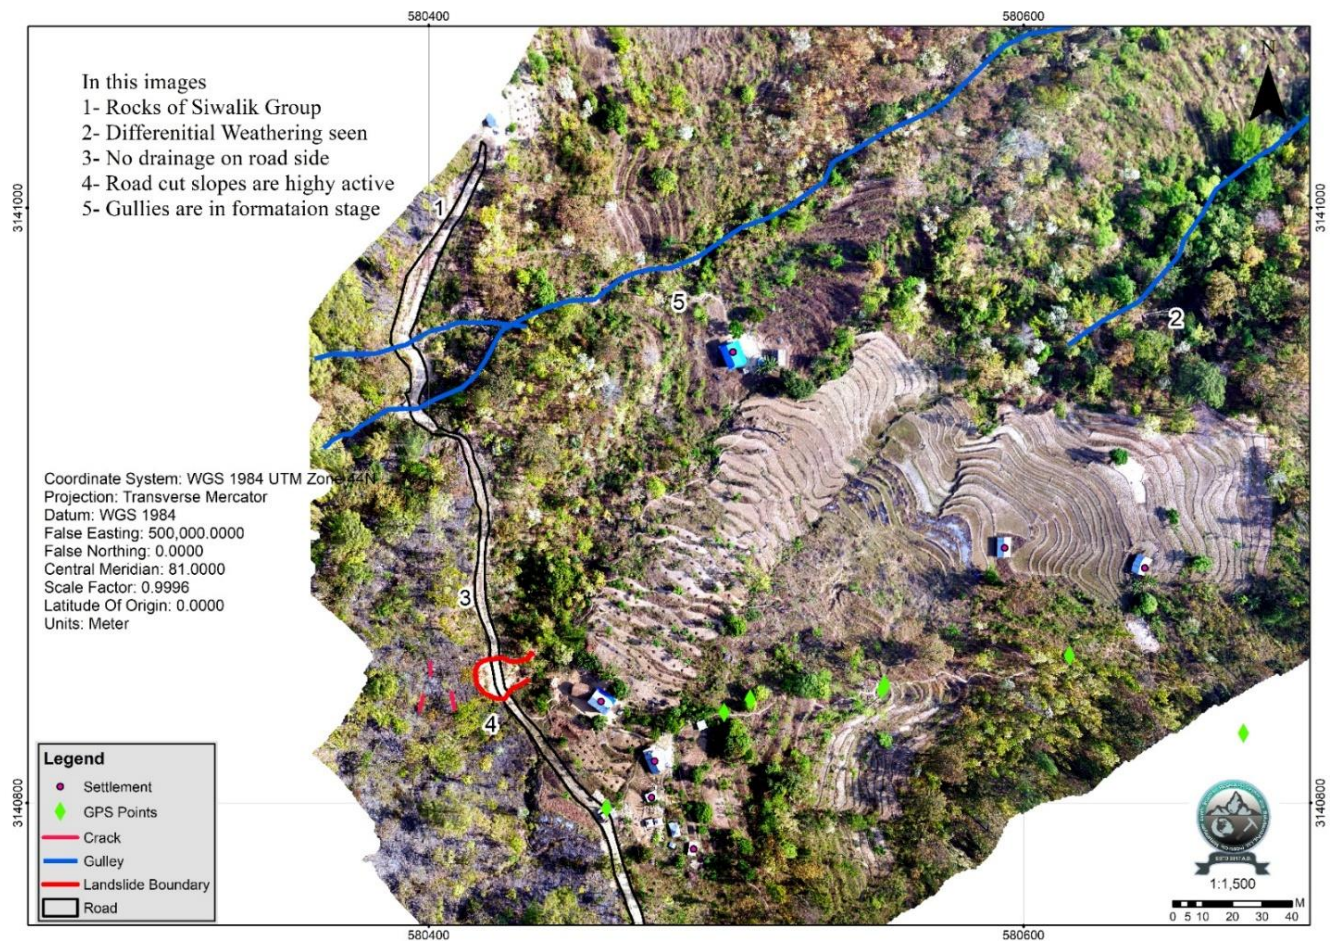
Figure 29: Photo Mosaic view with landslides boundaries from drone Images of Tilkeni/Sindhure Khola Landslide, Gurbhakot-06.

The major causes of the landslide include highly weathered mudstone, low-strength slope materials, haphazard road cutting practices, and inadequate drainage management. Road excavation without proper slope stabilization has significantly contributed to the development of slope instability in the area.

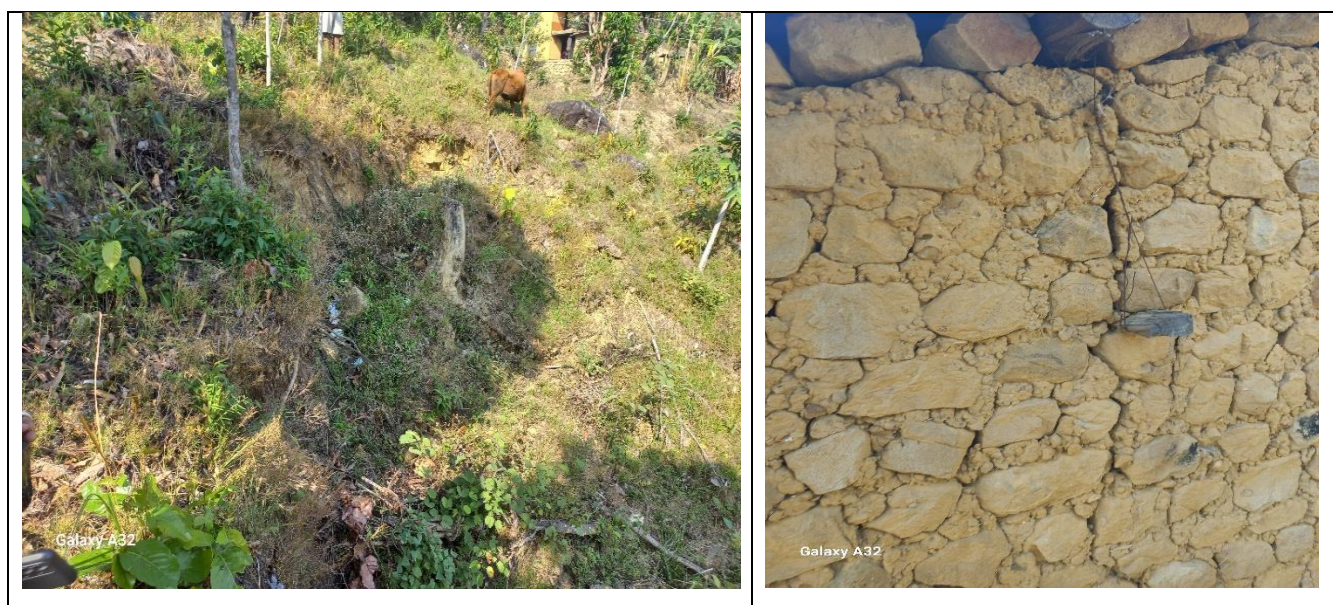
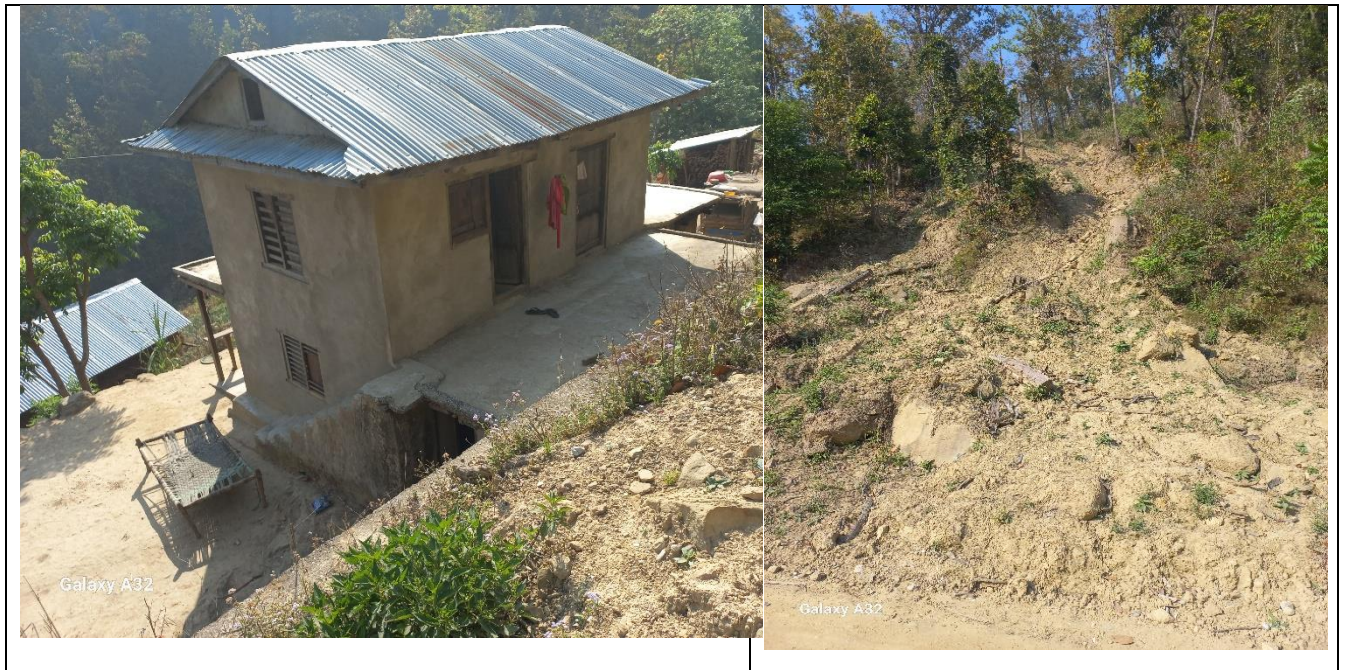
Figure 31: Cracks and displacement observed at the Tilkeni village and debris flow slides at the Sindure Khola road section

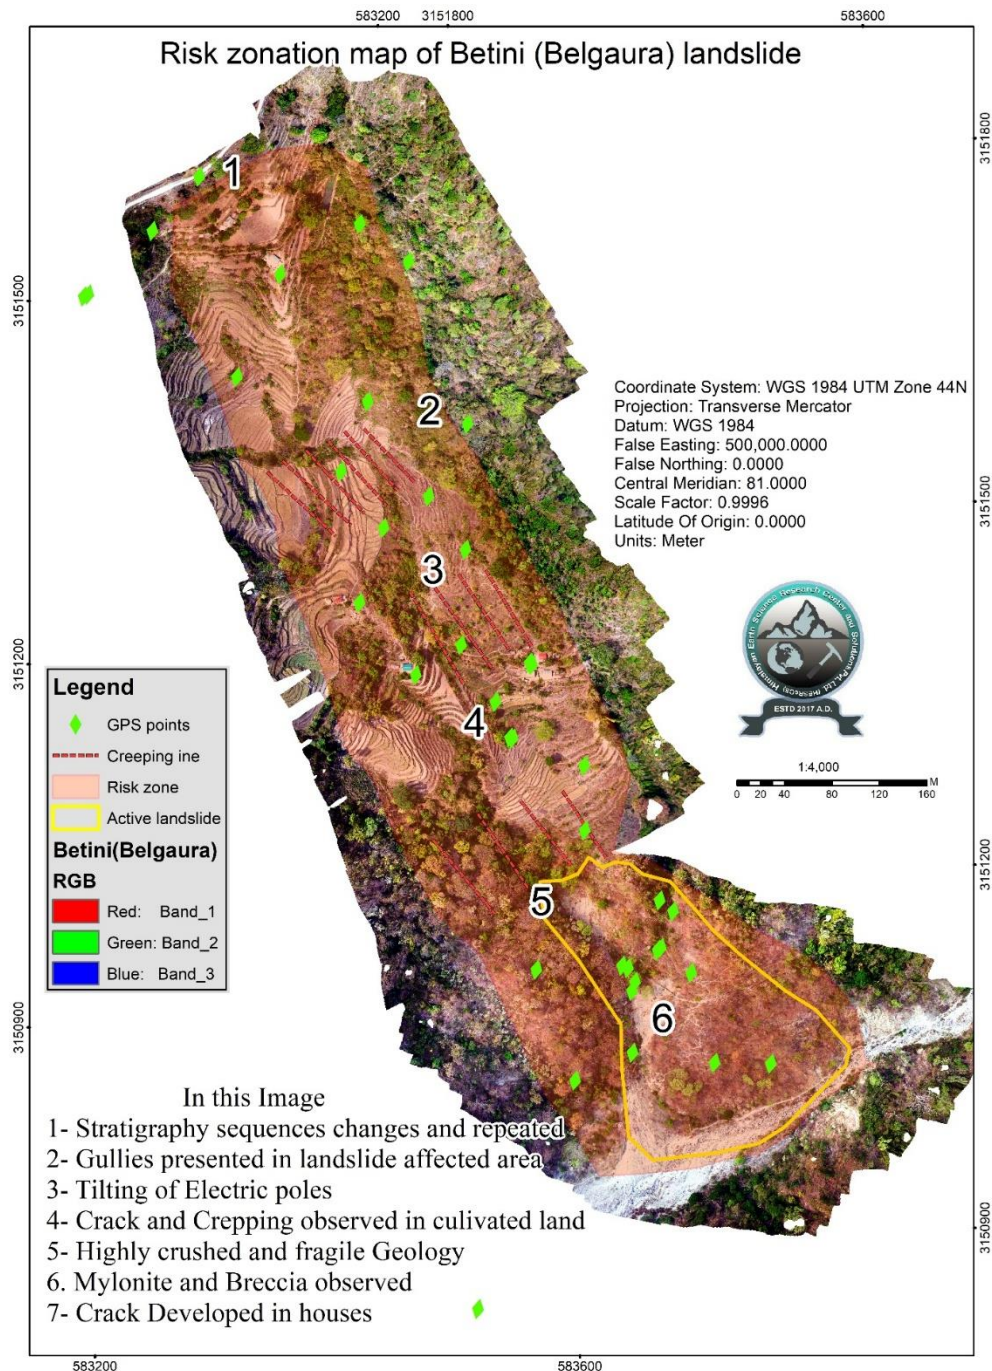
Figure 32: Photo Mosaic view with landslides boundaries from drone Images of Beteni/ Belgaura Landslide, Gurbhakot-14.

The geological condition of the area mainly consists of loose colluvial soil mixed with residual soil deposits. The main lithology consists of shale and phyllite with some Amphibolite. These materials are weak, unconsolidated, and highly susceptible to deformation during rainfall and saturation conditions. The landslide is identified as a paleo-creeping type landslide showing continuous yearly creeping movement. Tensional cracks and land subsidence were observed in several locations within the landslide area. This zone is located at the thrust zone of Main Boundary Thrust (MBT) which is considered to be active fault in the Nepal Himalaya.

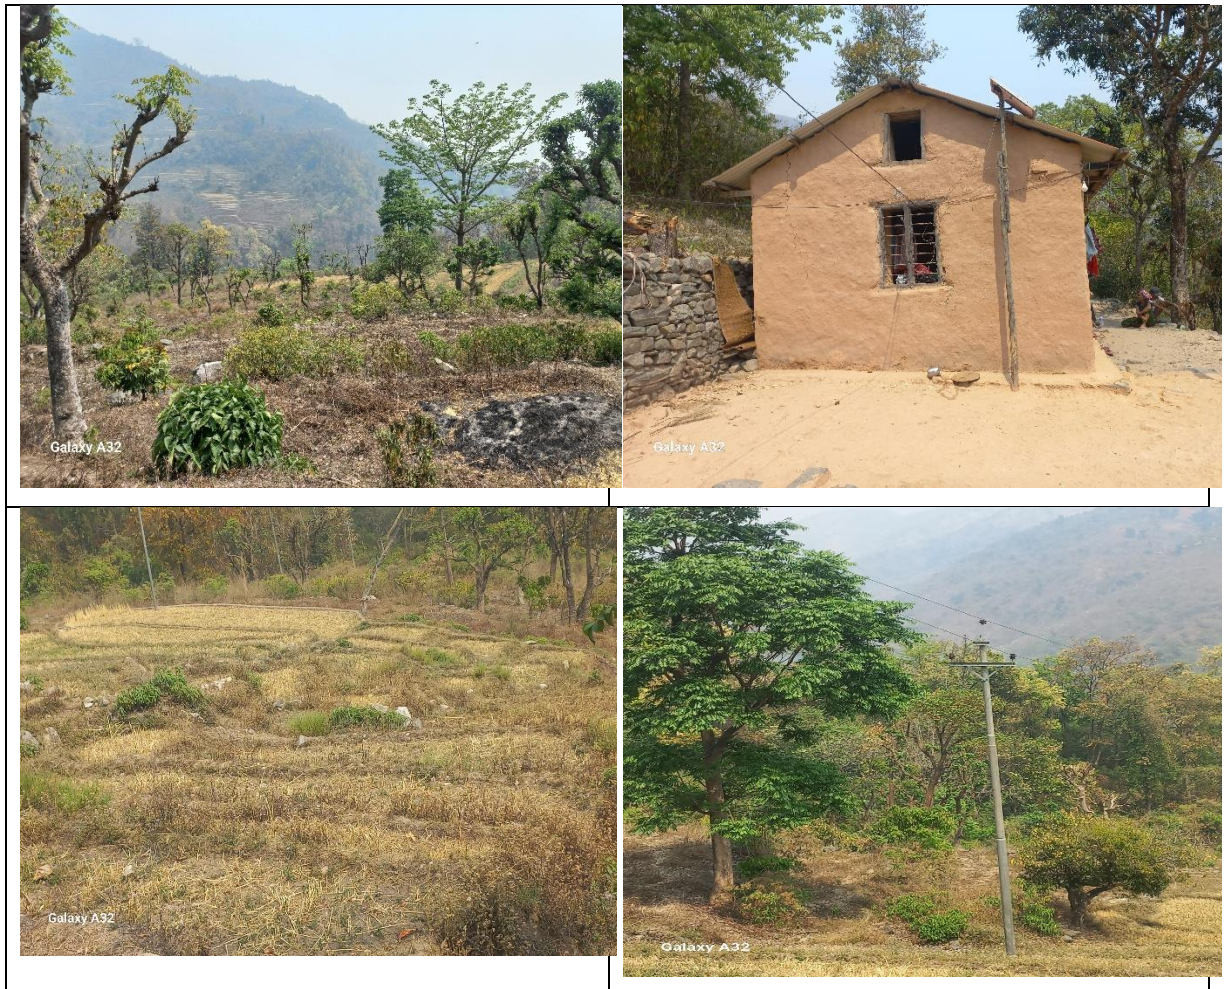
Figure 34 Photographs showing cracks, displacement of cultivated land and electric poles at the beteni/ Belgaura landslides area

| Treatability Status | The landslide is treatable with detailed engineering geological investigation and appropriate stabilization measures. |
