**Final Report**  
**On**  
**Geo-Hazard Assessment of Different Vulnerable Areas of**  
**Gurbhakot Municipality**  
**Surkhet District**  
**Karnali Province**

**Submitted to**  
**Local Initiatives for Biodiversity, Research and Development (LI-BIRD)**

**Submitted by**  
**Himalayan Earth Science Research Center and Solutions Pvt. Ltd**

**2026**

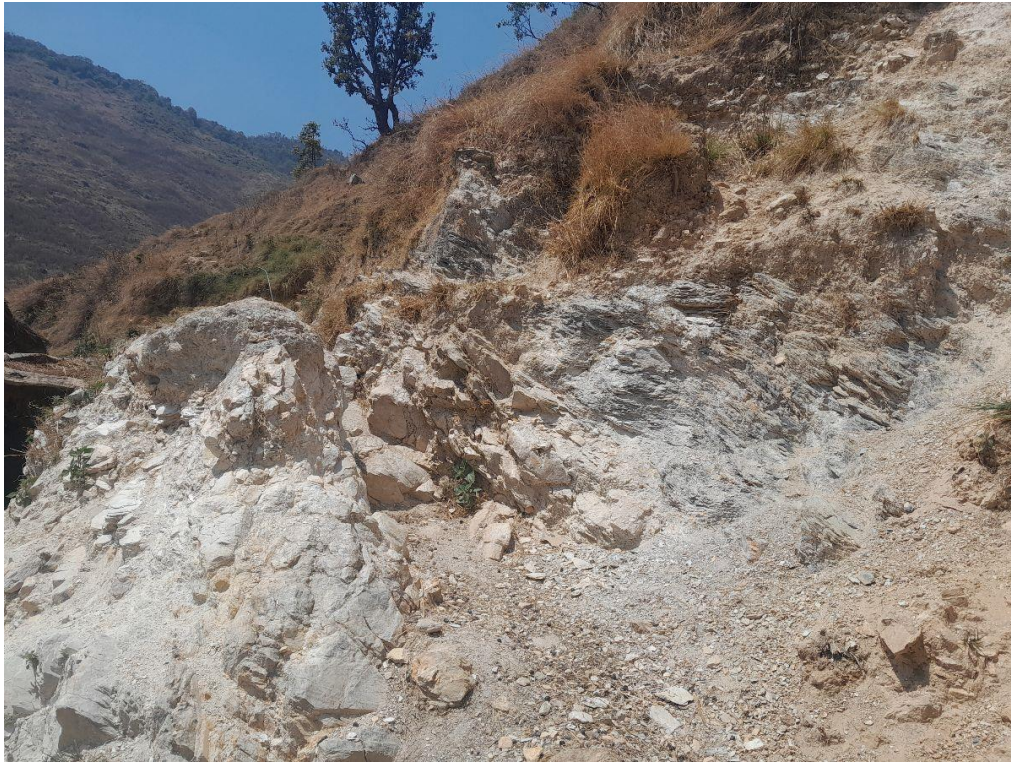
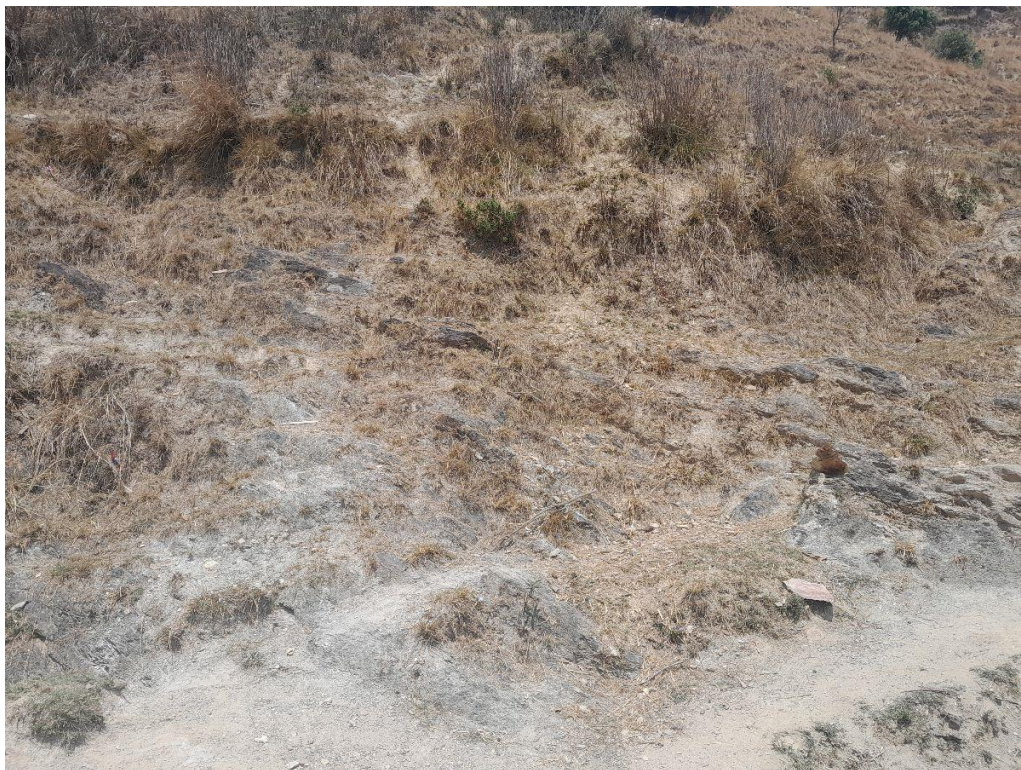
Highly weathered and fractured bedrock exposed in Khola Dhab.

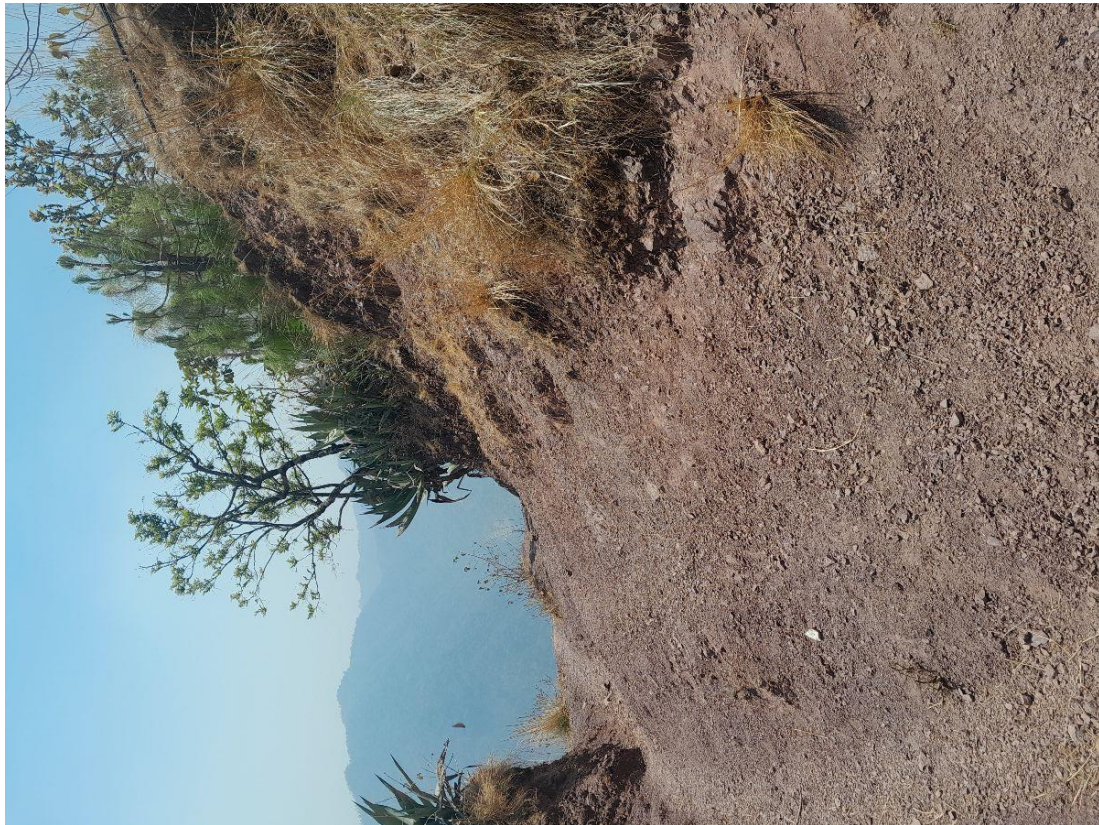
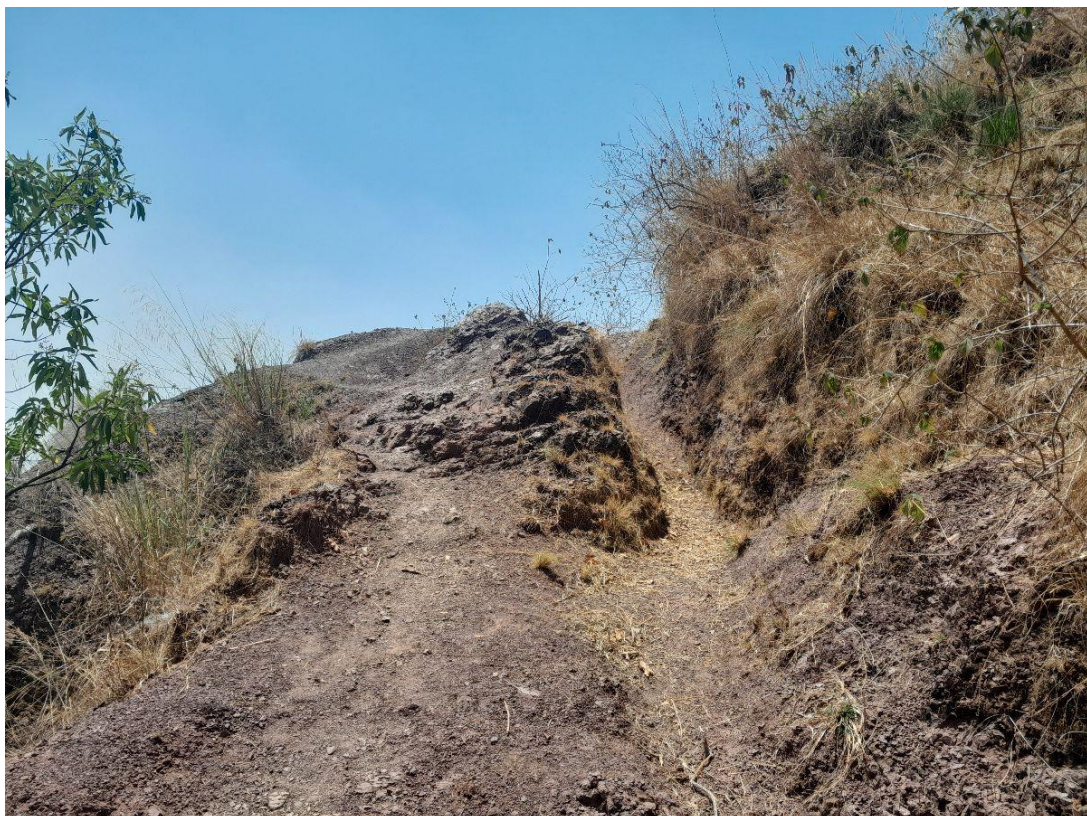
Highly weathered purple shale observed in the top portion of Lekh Malarani.

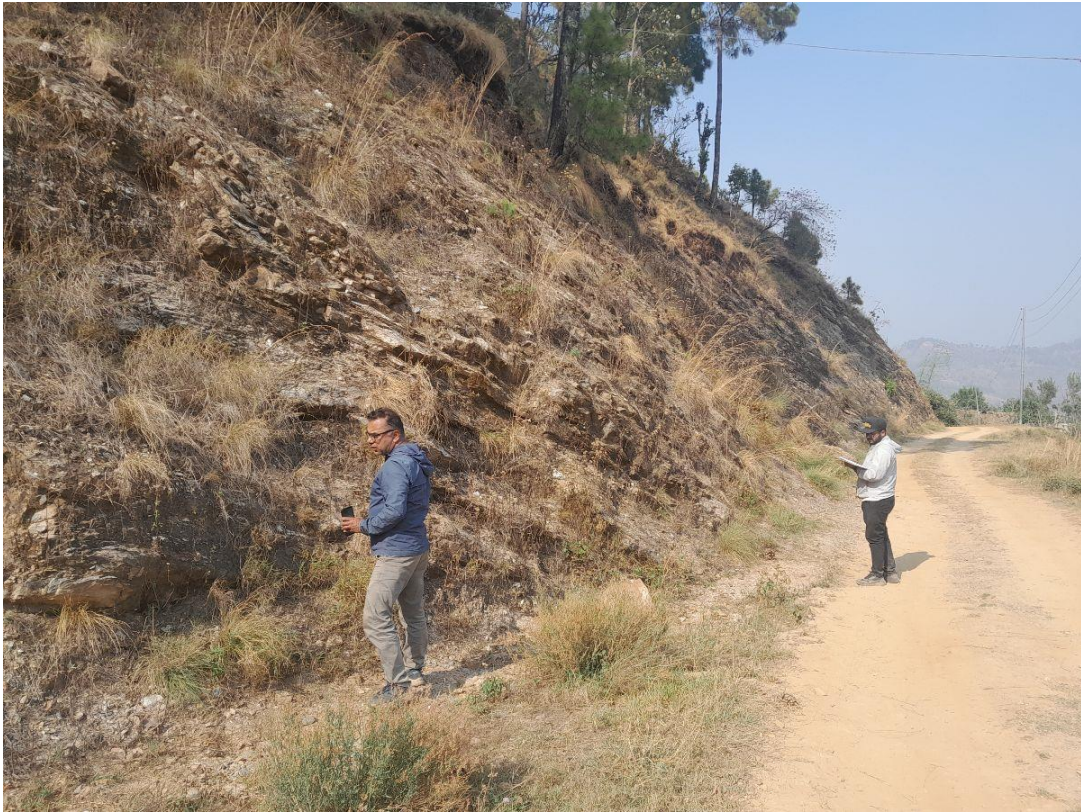
Bedrock exposed in Hile landslide in the road cut section.

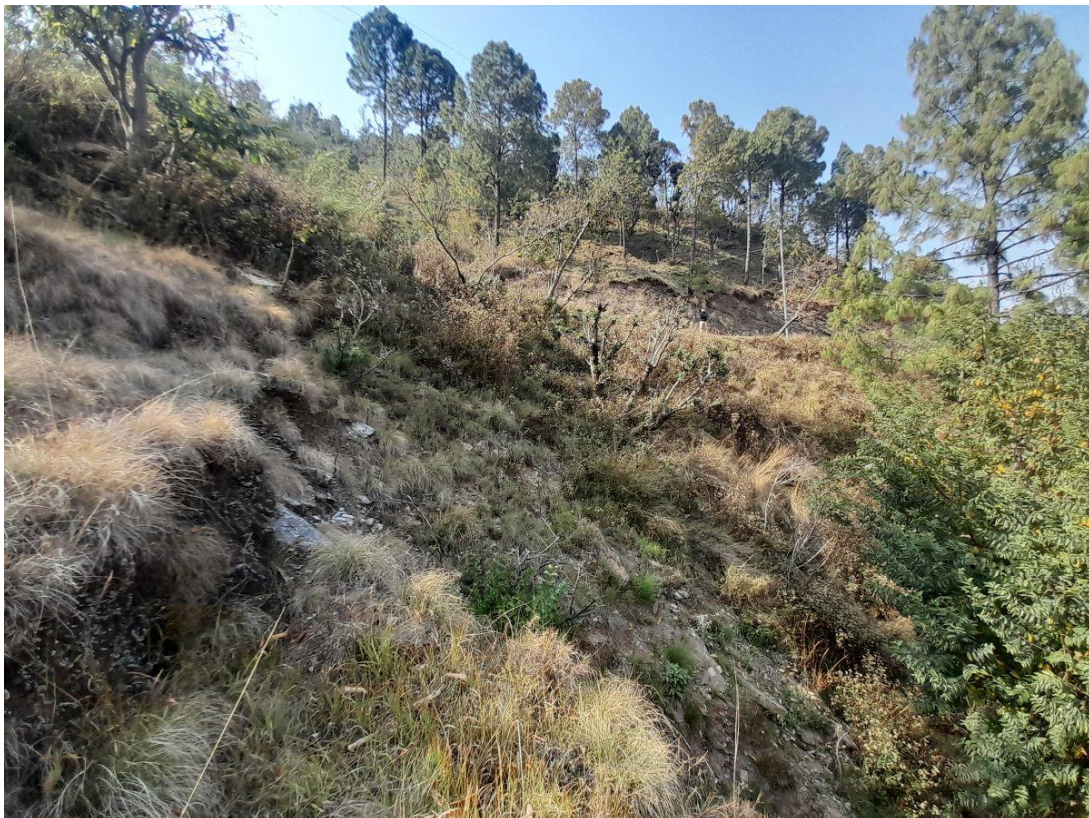
Deformed slope mass in Hile landslide down slope of the road.

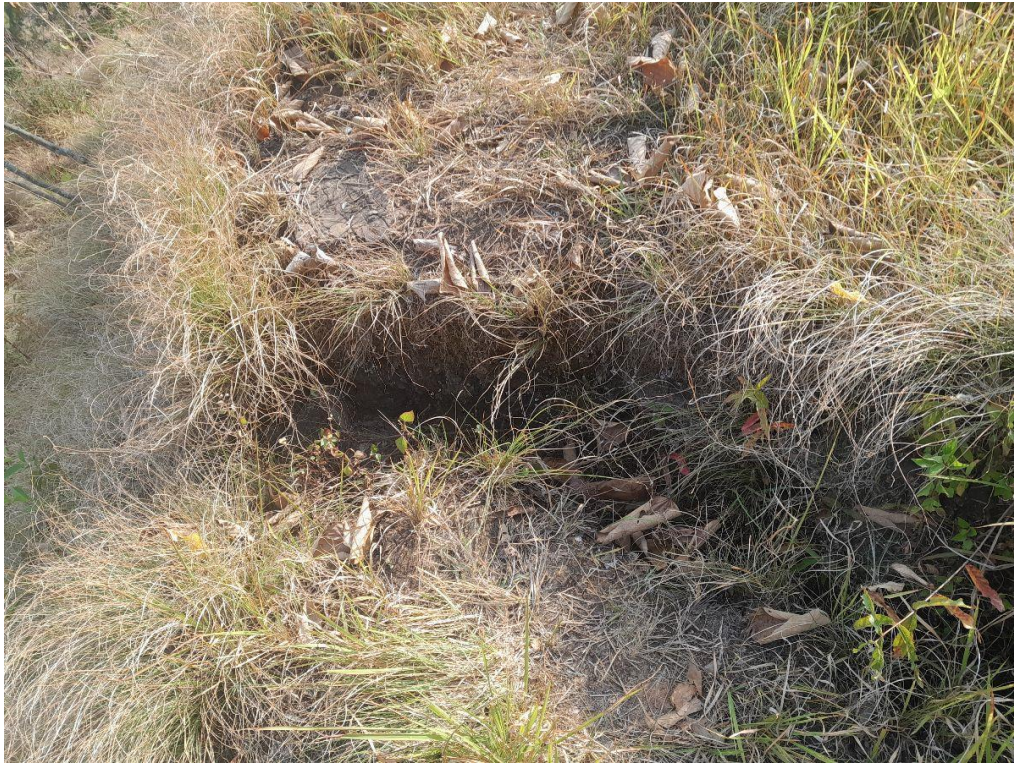
Subsidence and crack seen in the downslope of the road near gully of Hile landslide.

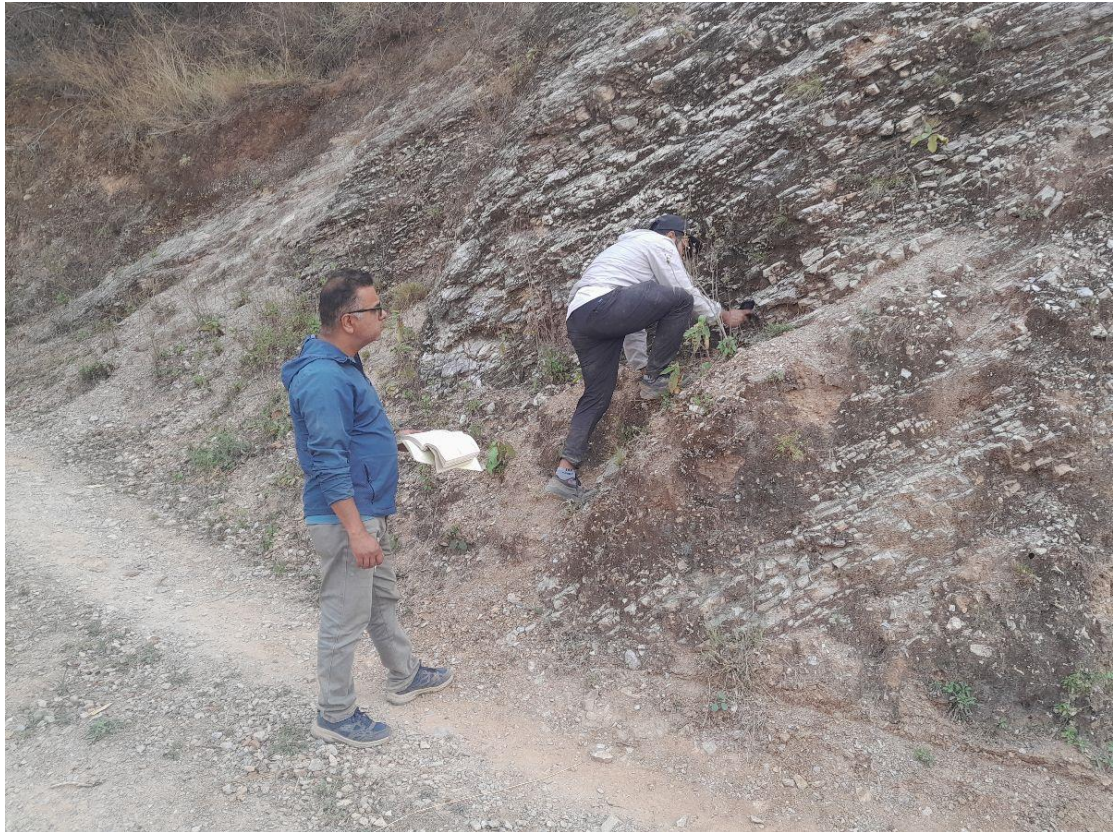
Bedrock exposed and data measurement in Lek Kurile landslide.

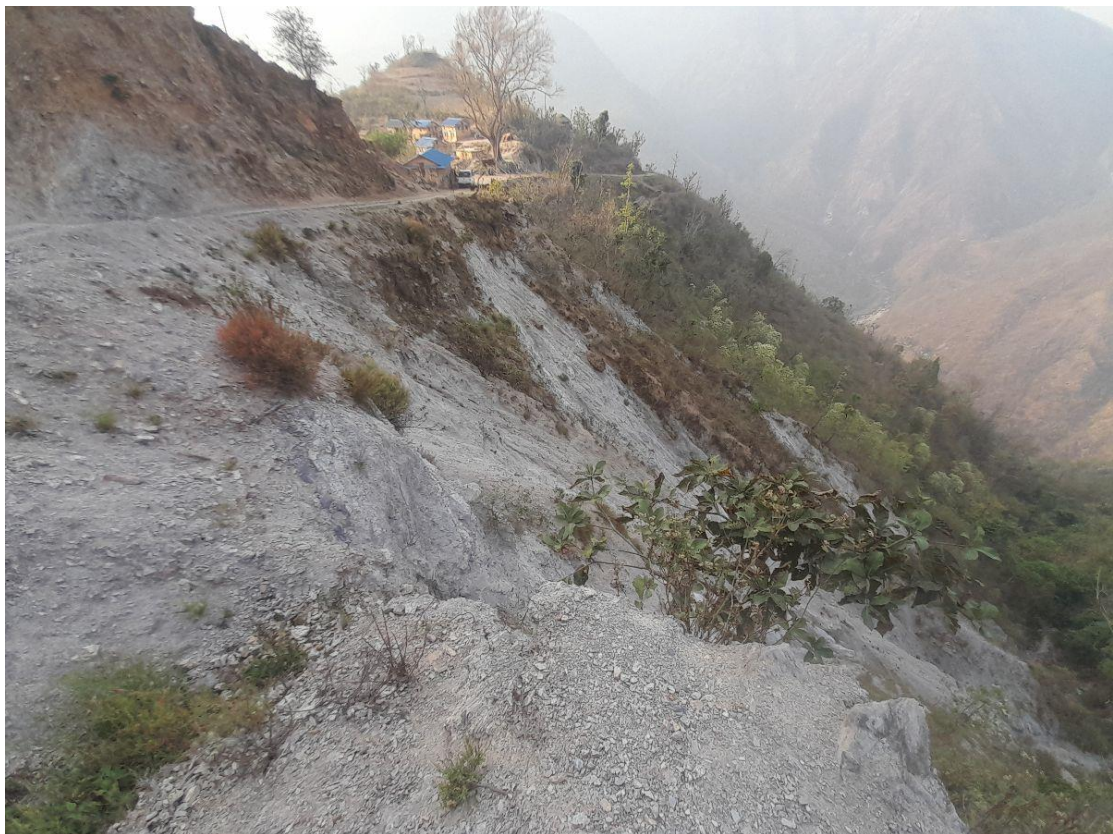
Landslide overview of Lek Kurile landslide.

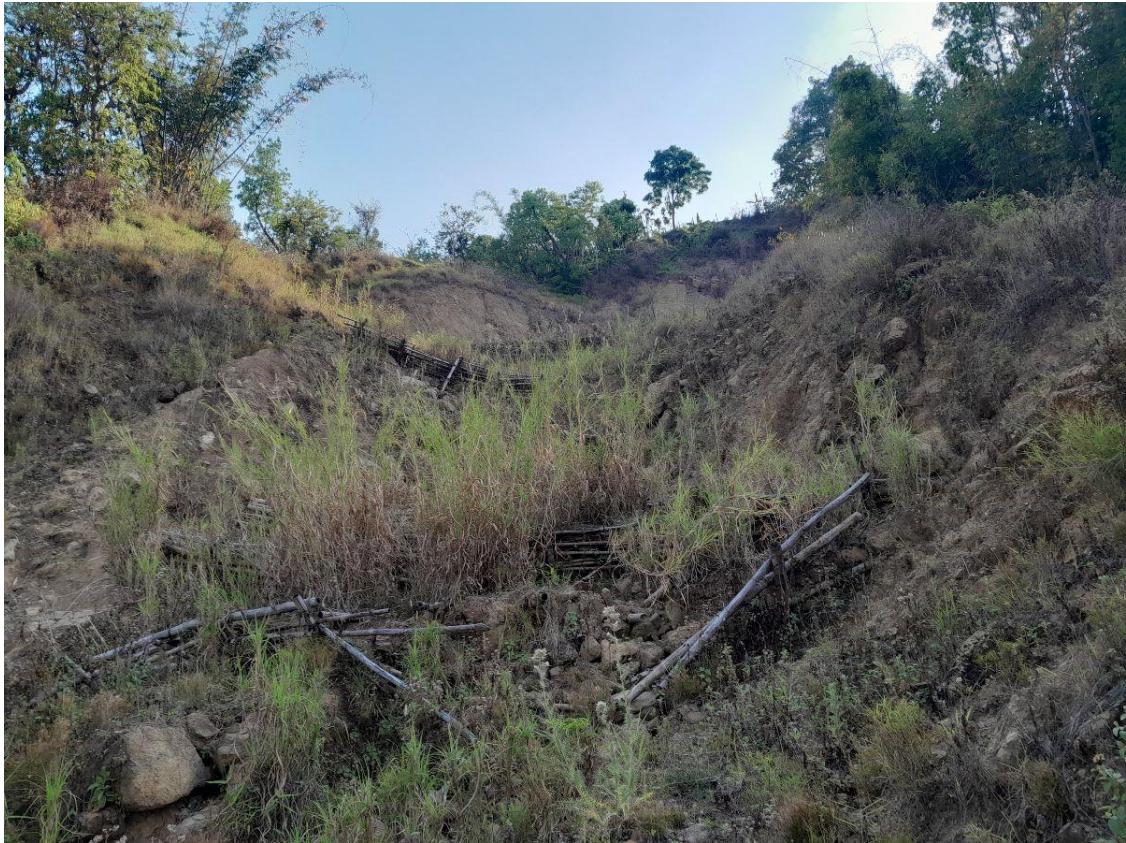
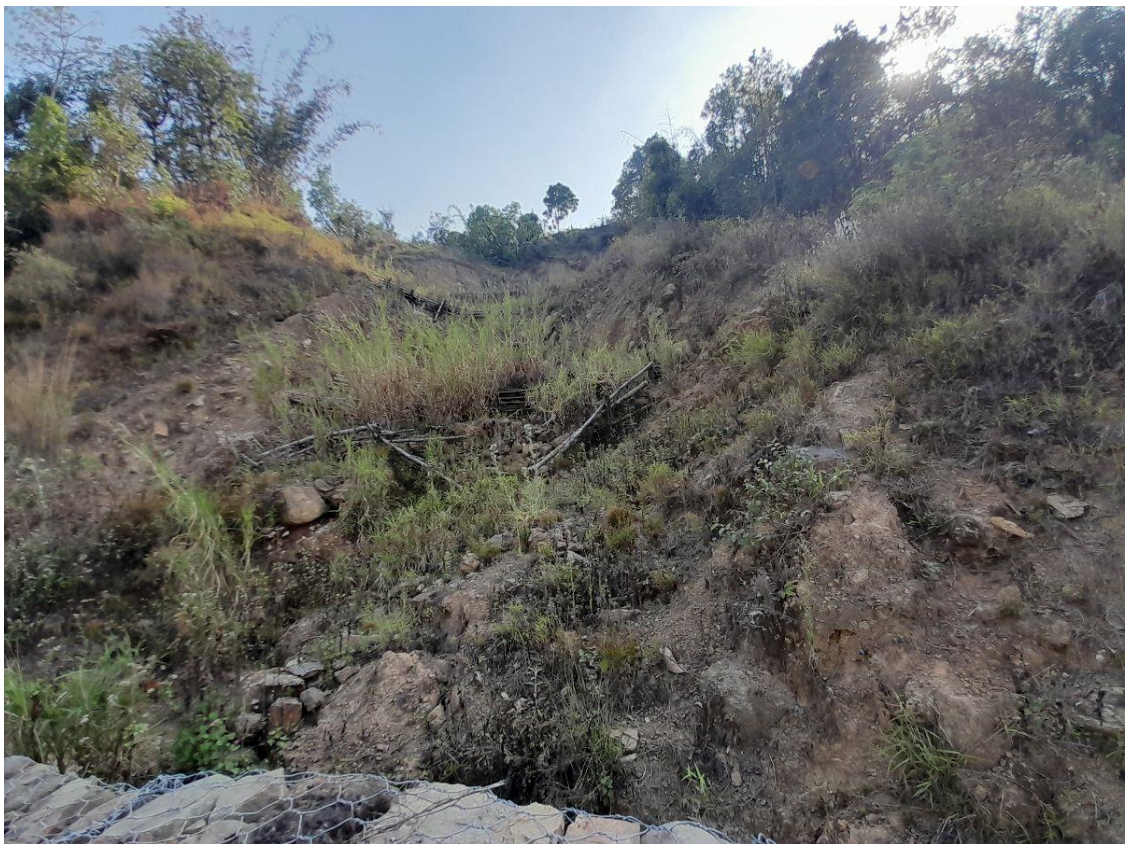
Disturbed bio-engineering structures present in the up slope of the road in crown part of Pokharepata Landslide.

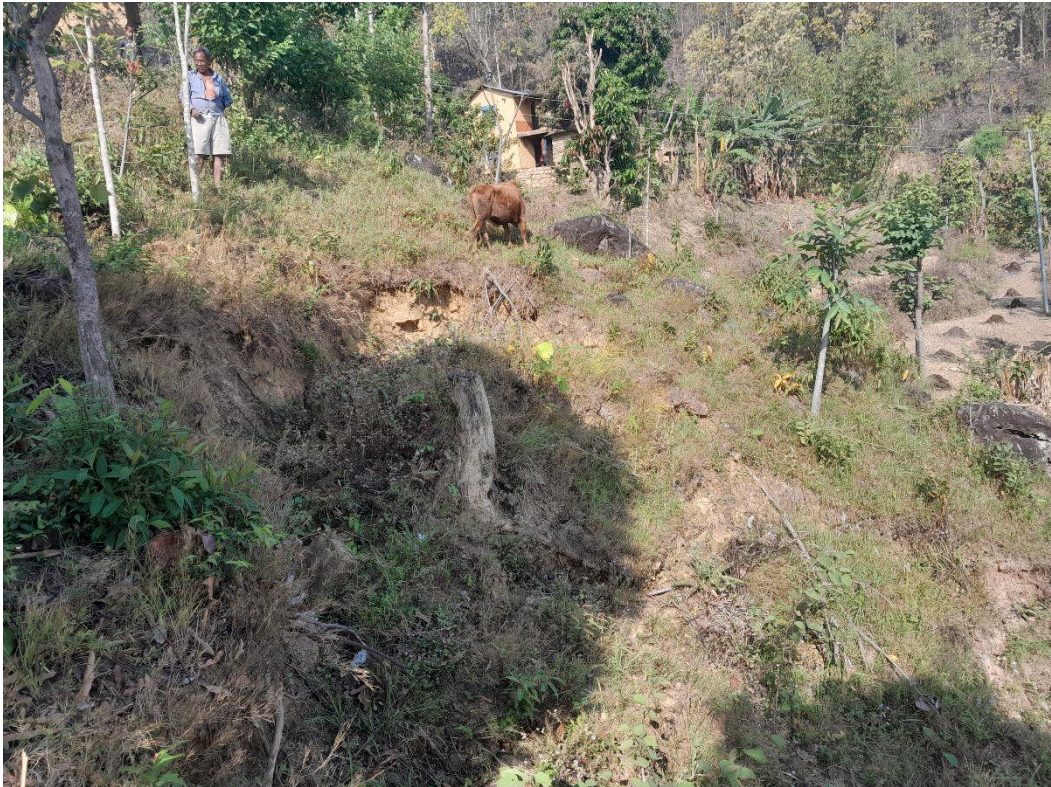
Small scarp initiated by Jajarkot earthquake, downslope of the settlement, Sindhure khola

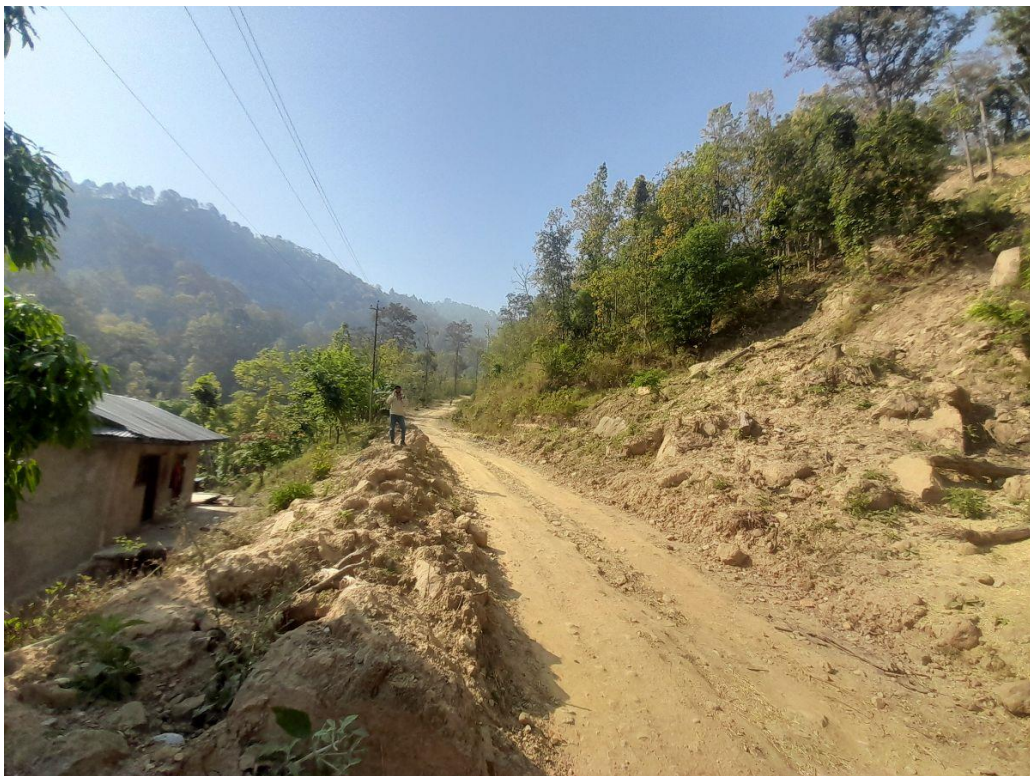
Debris flow, Sindhure khola.
