**Final Report**  
**On**  
**Geo-Hazard Assessment of Different Vulnerable Areas of**  
**Gurbhakot Municipality**  
**Surkhet District**  
**Karnali Province**

**Submitted to**  
**Local Initiatives for Biodiversity, Research and Development (LI-BIRD)**

**Submitted by**  
**Himalayan Earth Science Research Center and Solutions Pvt. Ltd**

**2026**

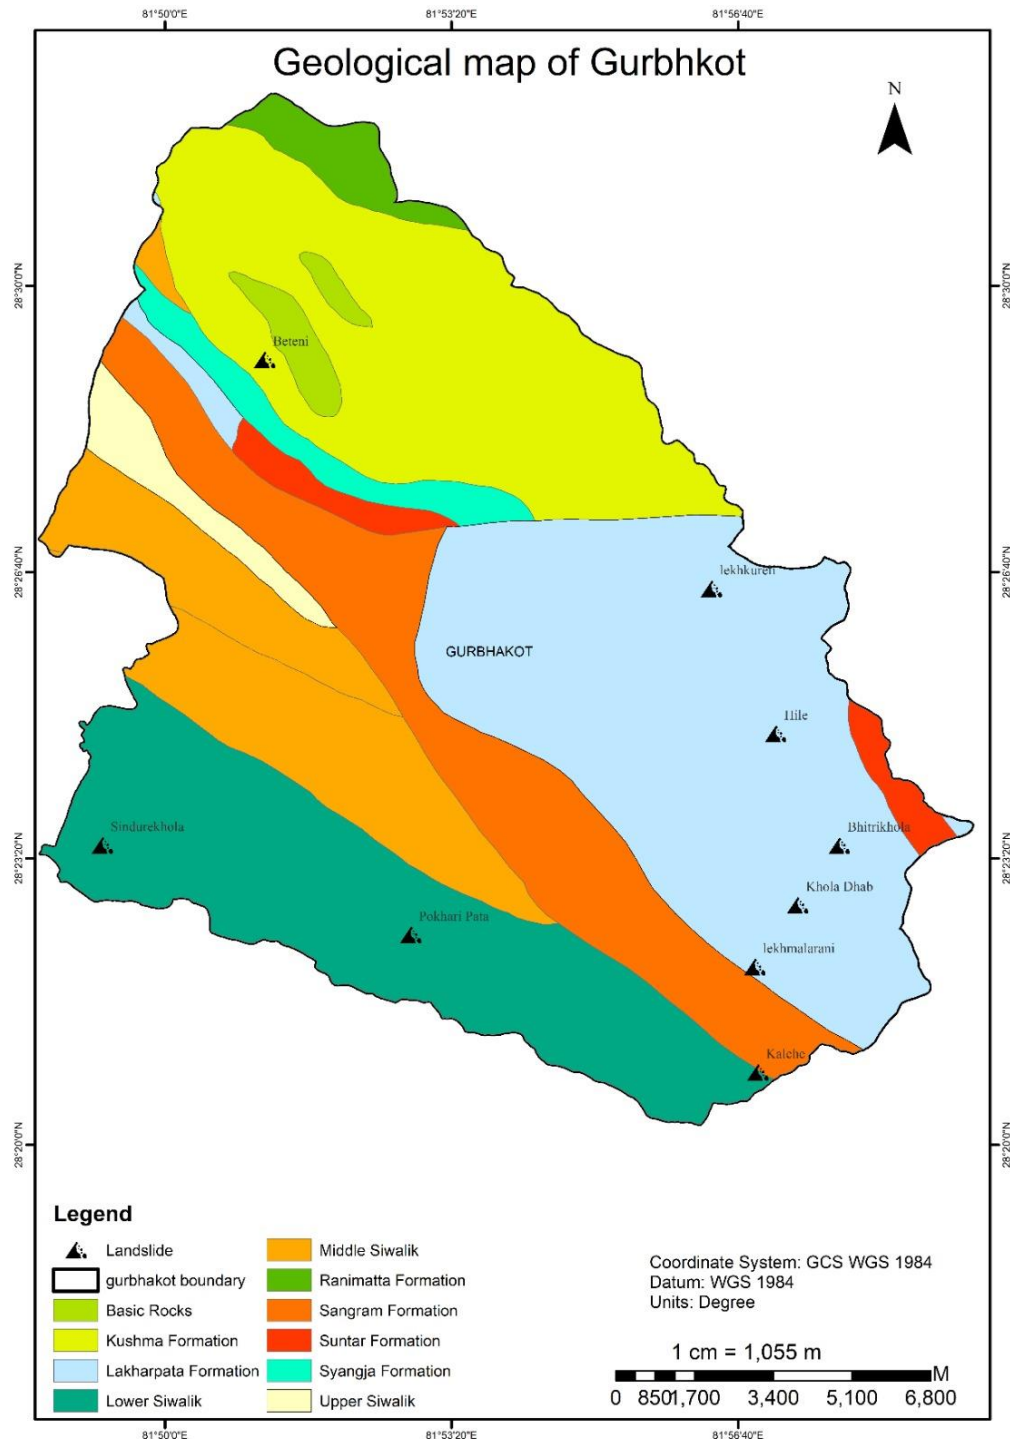
Figure 9: General Geological Map of the study area

The geology of the Gurbhakot area (Figure 9) represents a structurally complex transition between the Sub-Himalayan (Siwalik) zone and the Lesser Himalaya. The area is dominated by sedimentary rocks of the Siwalik Group, which include mudstone intercalated with sandstone in the Lower Siwalik, medium- to coarse-grained sandstone with mudstone and occasional pebbles in the Middle Siwalik, and conglomerates in the Upper Siwalik. These rocks are generally weakly consolidated and highly susceptible to weathering and erosion, making them prone to slope instability.

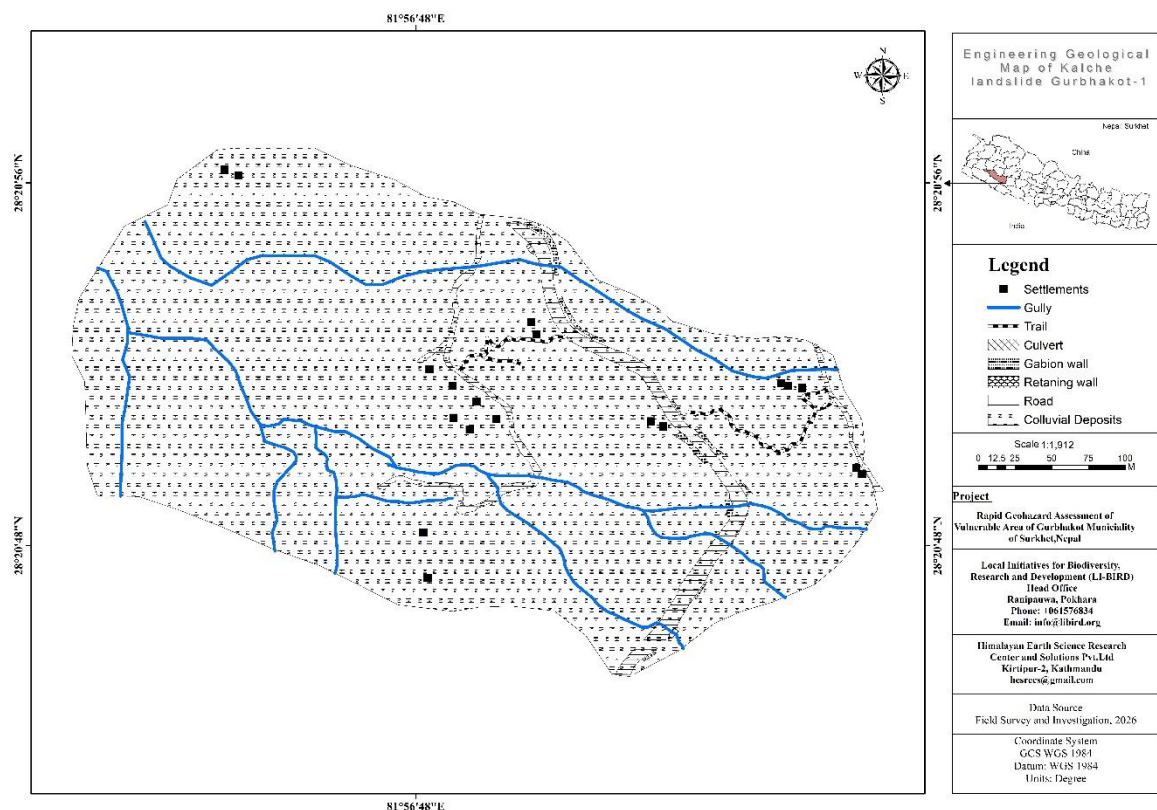
Figure 11: Engineering Geological map of Kalche landslide, Gurbhakot-1

Field observations indicate the presence of tension cracks at both the crown and within the main body of the landslide, suggesting past movement and potential for reactivation. Although no active movement is currently observed, the slope remains vulnerable.
